**BUILDING SURVEY EXAMINATION
AND
REPORT**

**60 GELLI ROAD
PENTRE
S.WALES
CF41 7ND**

**Carried out by
Mr Jeffrey R Tucker, M.R.I.C.S.
Chartered Building Surveyor**

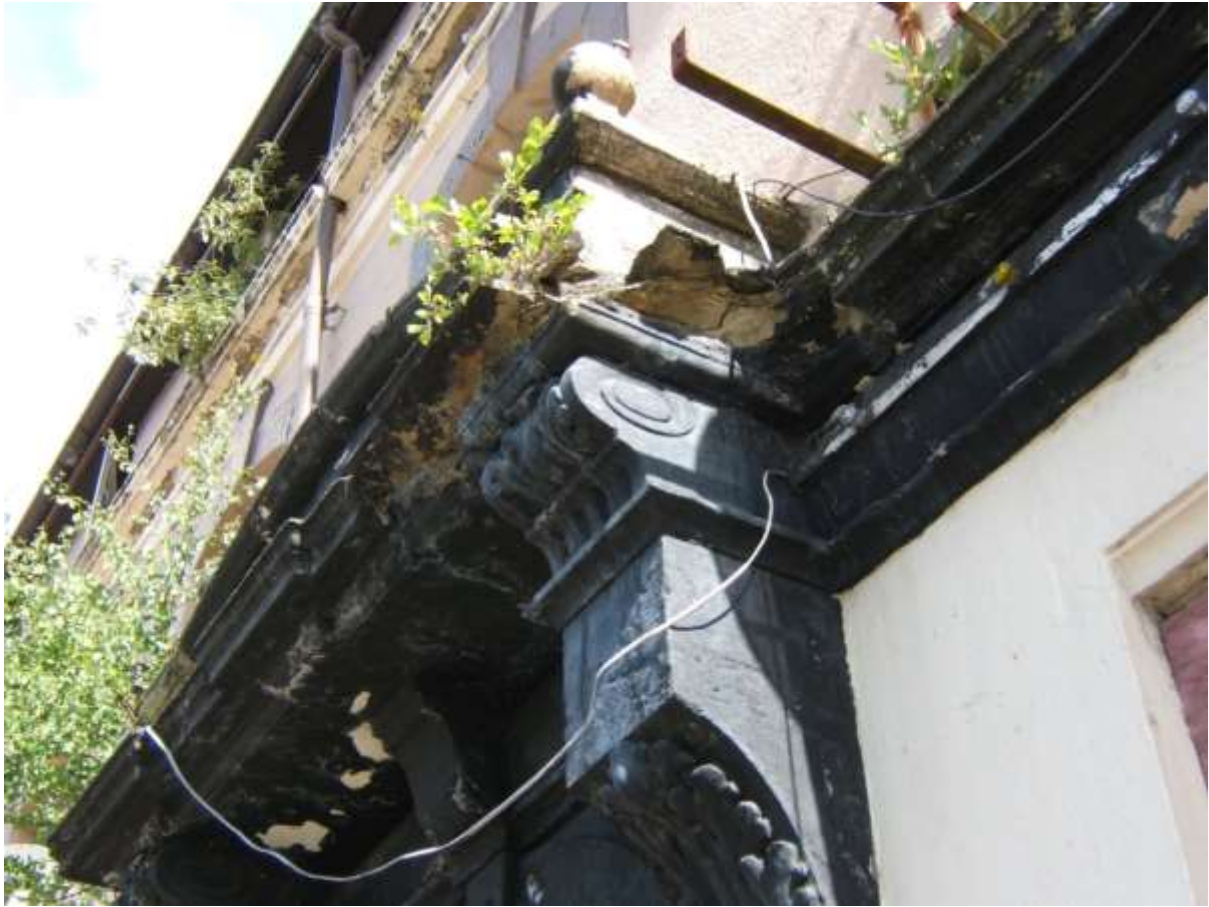
Sandstone entrance canopy with areas of stonework laminating.

LAMINATING SANDSTONE AT FRONT ENTRANCE CANOPY & PLANT GROWTH TO BE REMOVED

This requires stabilizing to prevent ongoing deterioration of the feature canopy and should include a lead cloak over the top to prevent ongoing water penetration through the stonework.

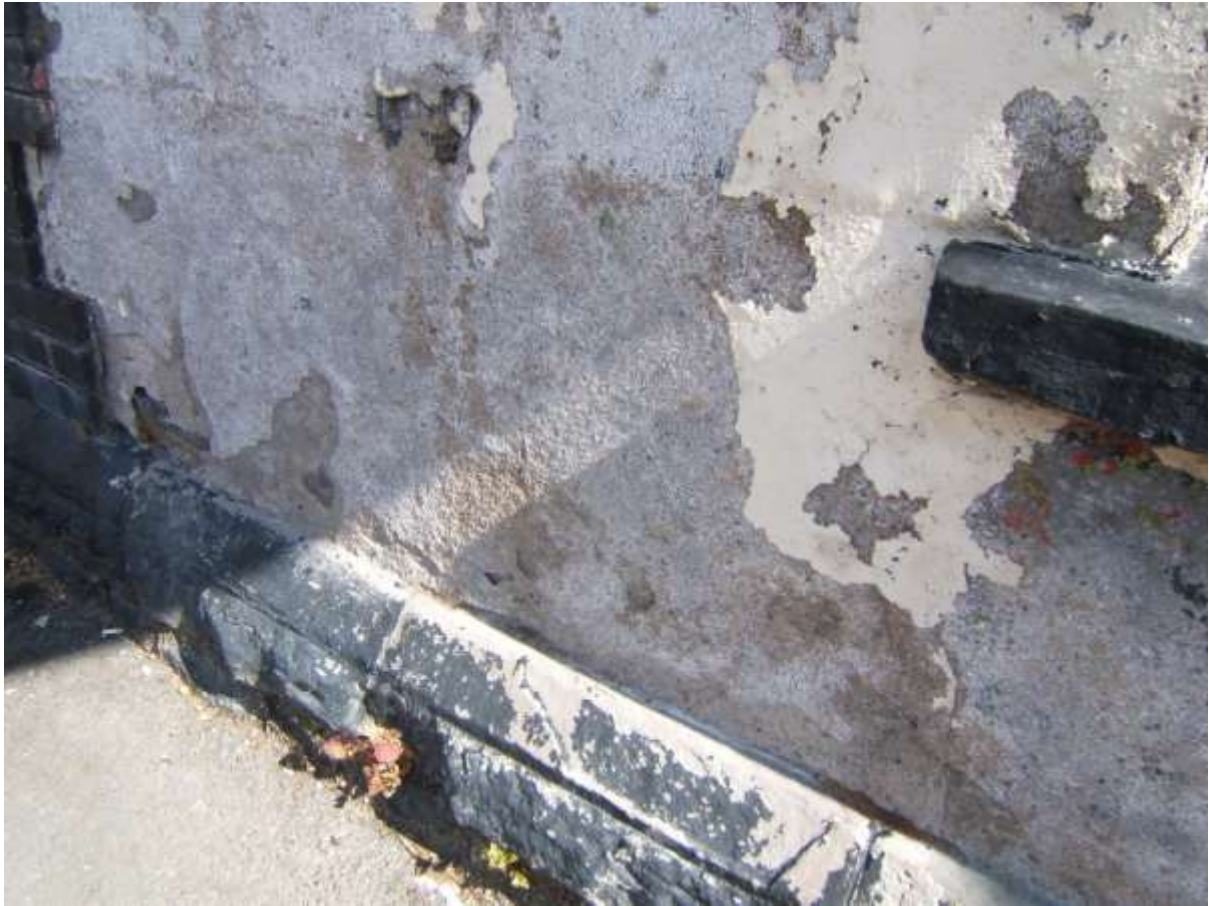
Render defects at low level on LHS

RENDER DEFECTS TO FRONT WALL AT L.H.S.

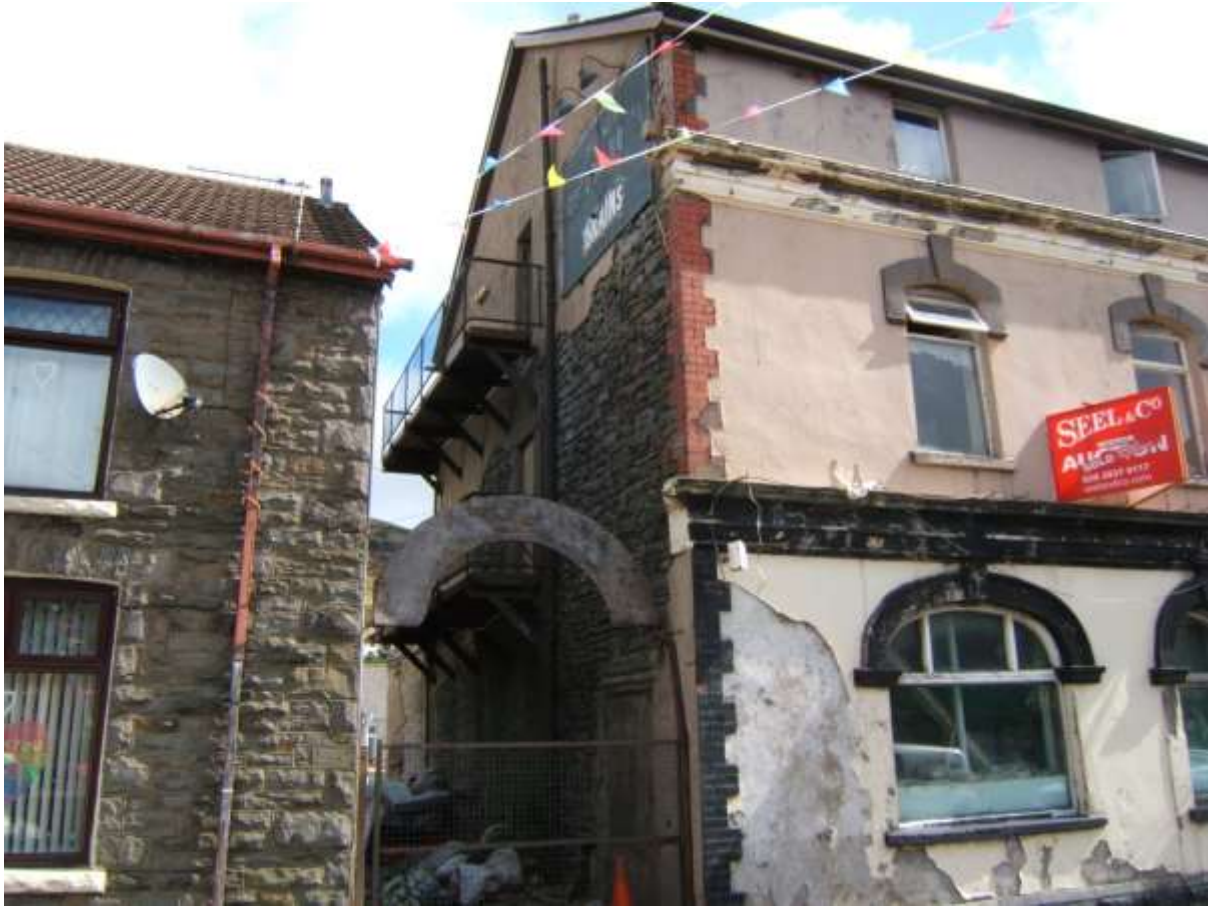
Render missing generally throughout.

SIDE GABLE WALL SHOWING DEFECTIVE RENDER

Re render entire wall.

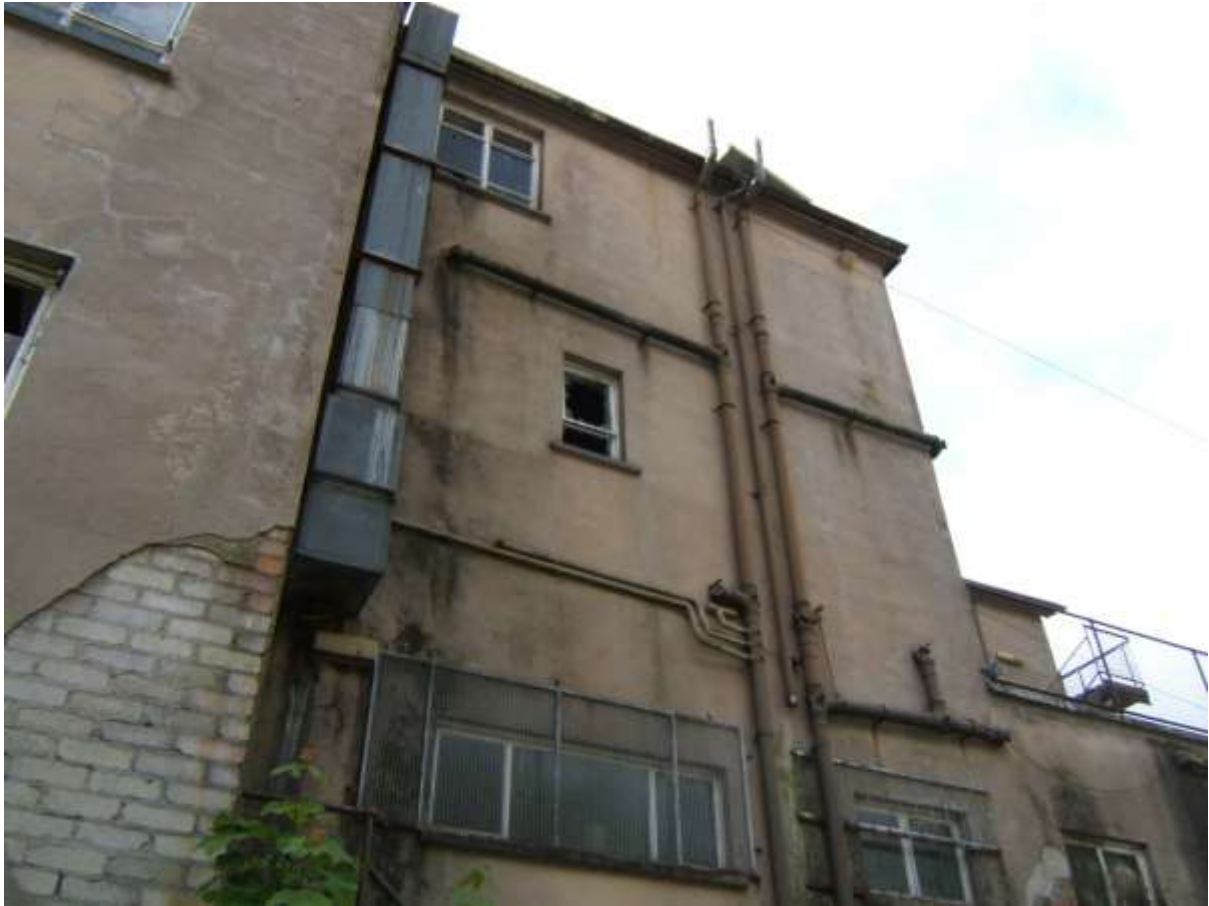
UPPER REAR ELEVATION WITH RENDER DEFECTS TO WALL

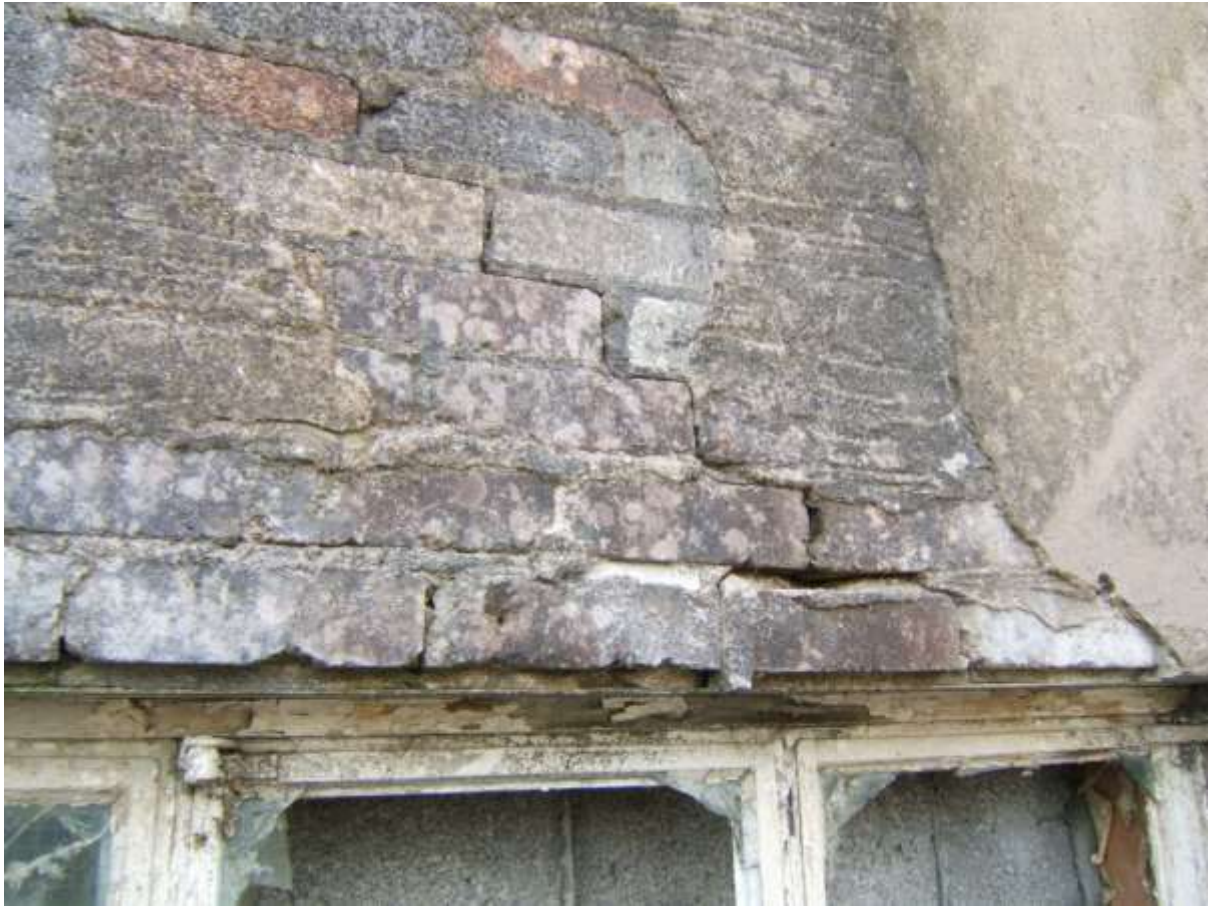
Fractured and settled brickwork above RHS window head. This will require repointing or reforming to provide a satisfactory brick bond above the window head.

COLLAPSE OF BRICKWORK & LOSS OF BRICK BOND ABOVE R.H.S. REAR WIDE WINDOW ON GROUND FLOOR

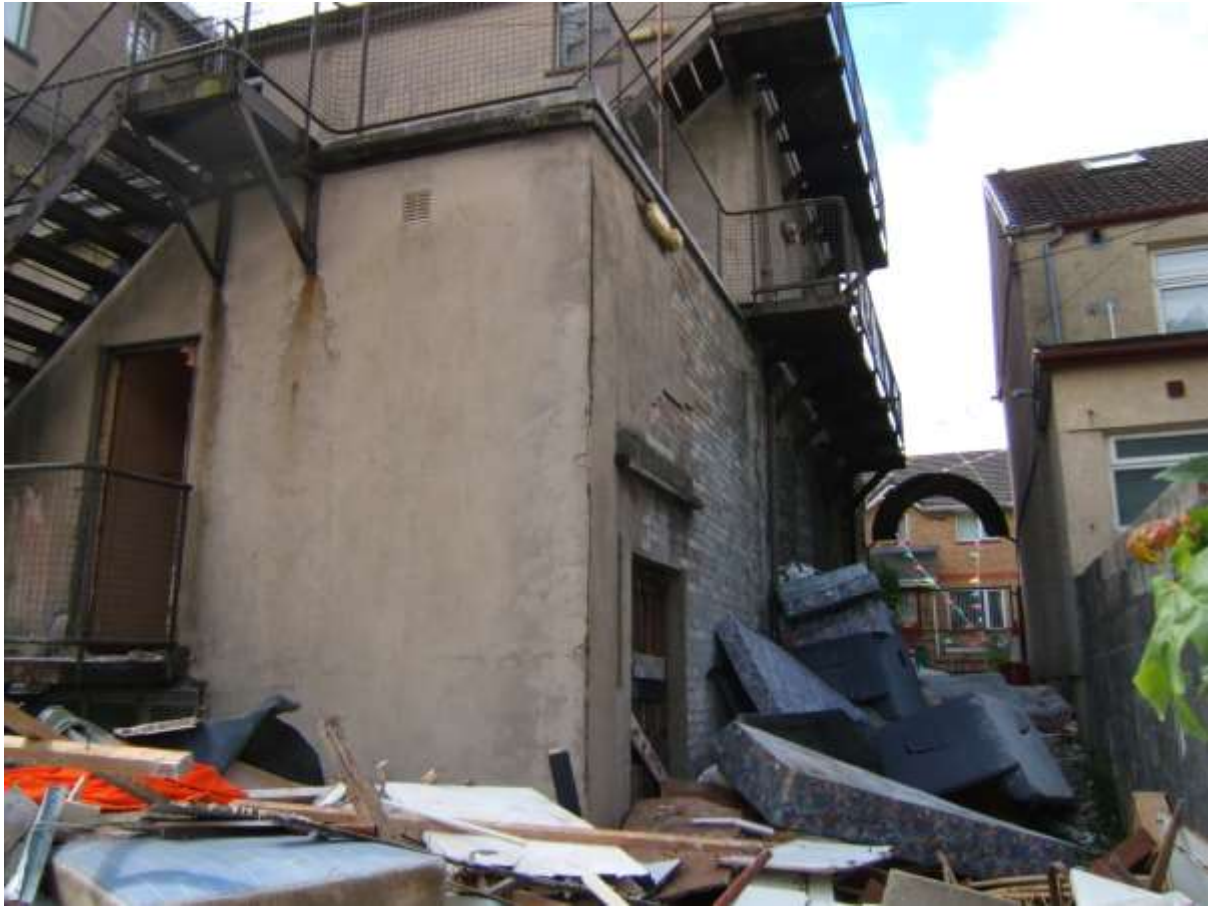
REAR NORTH EAST CORNER WITH RENDER DEFECTS TO BOTH WALLS

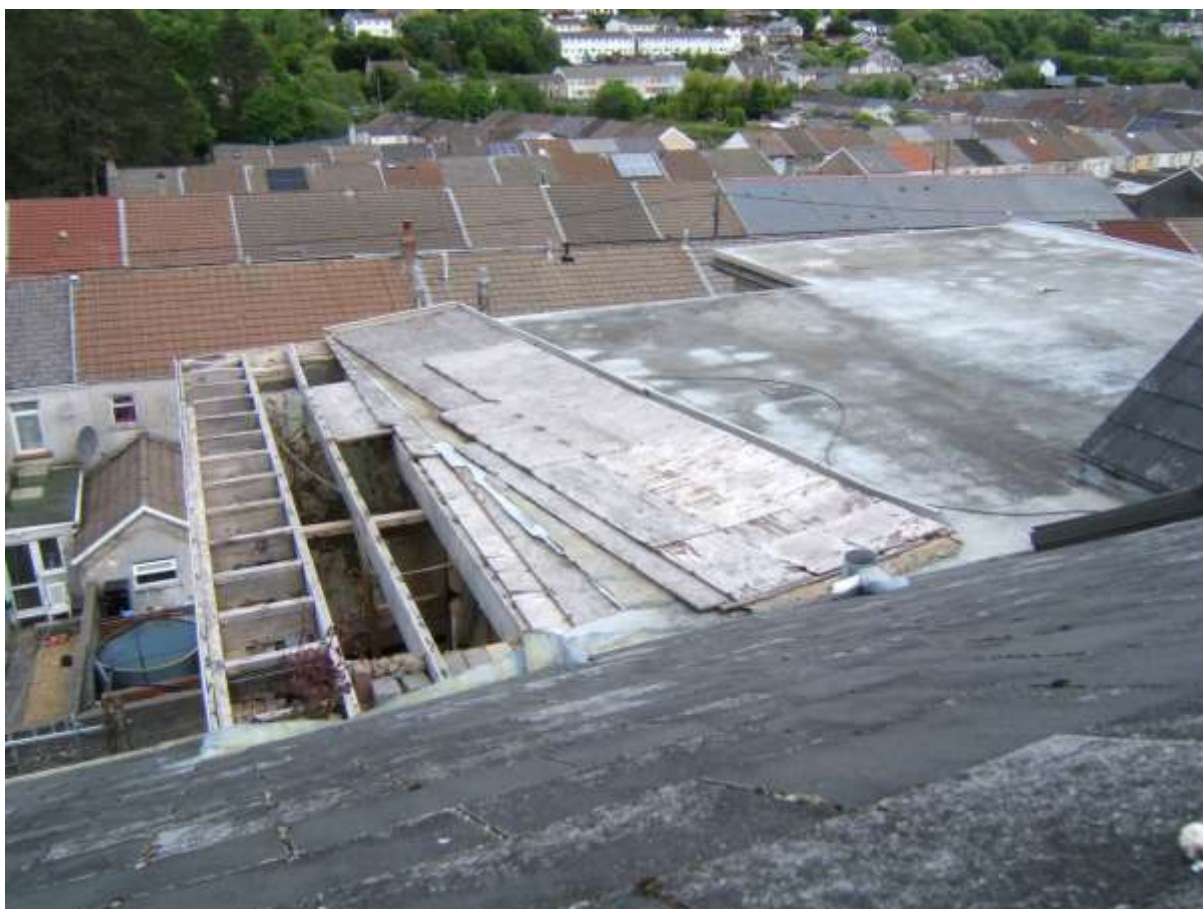
There is also damage to the upper flat roof which has been blown off allowing significant water ingress at the rear through all floors.

Area of flat roof missing along northern side allowing water ingress to building fabric.

DAMAGED UPPER FLAT ROOF AT REAR

The flat roof at the rear requires immediate repair to prevent ongoing water damage internally along with all flashings being replaced around the roof junctions.

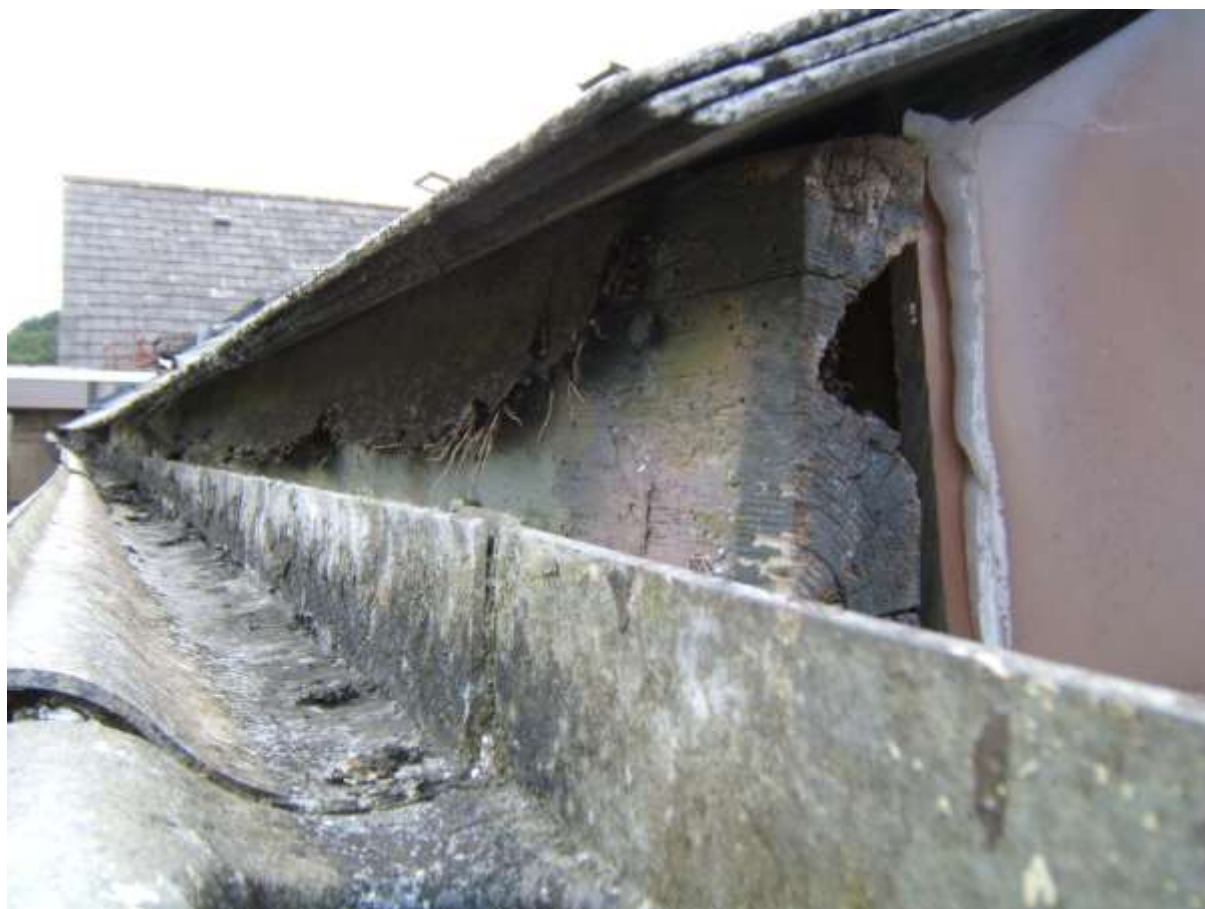
Woodworm and deterioration of timber members generally.

TIMBER FASCIA AT REAR UPPER MAIN ROOF EDGE WITH WOODWORM & ROT

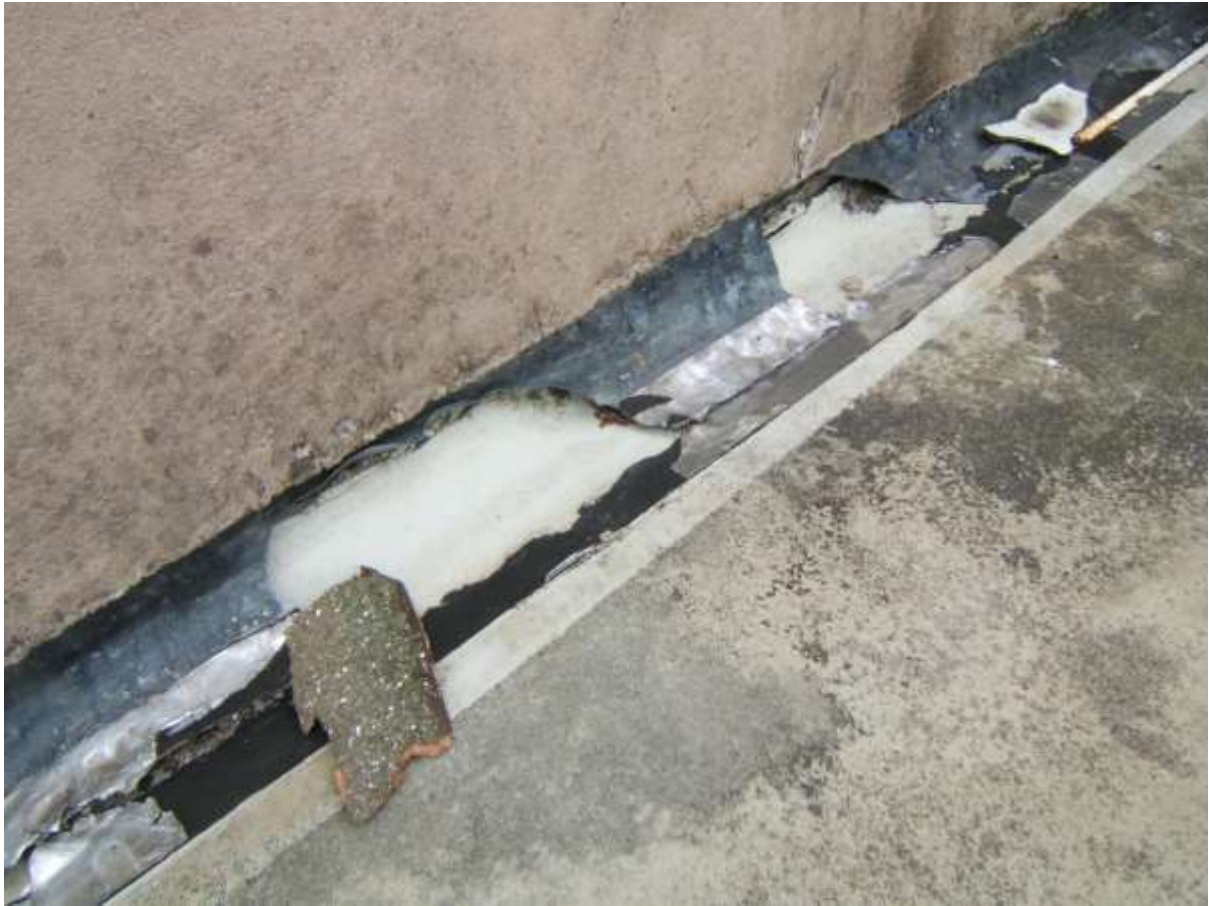
Lead flashing missing at base of wall at junction with flat roof.

MISSING LEAD FLASHING AT LOWER FLAT ROOF JUNCTION WITH WALL

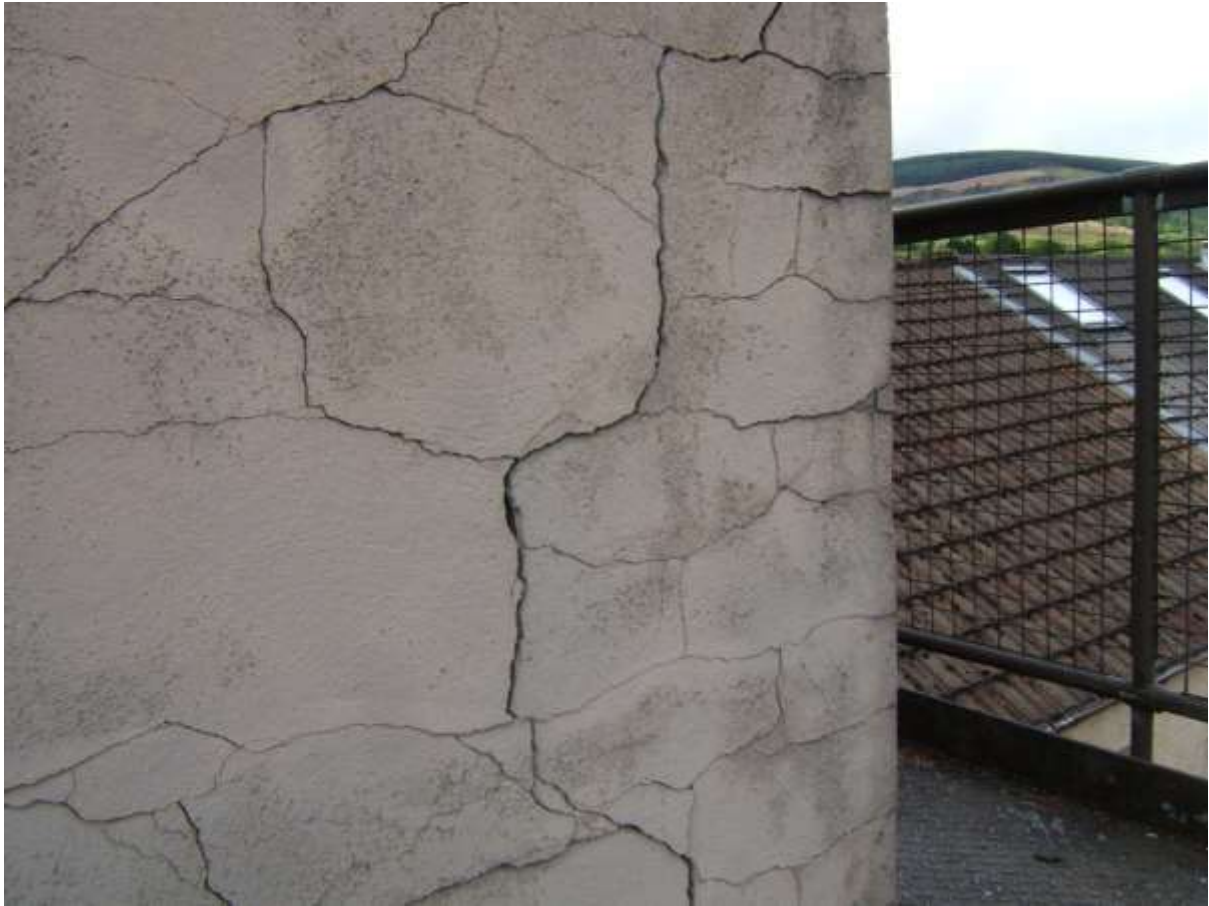
Fractured render to upper RHS rear corner above steel escape platform.

RENDER FAILURE AT REAR UPPER NORTH EAST CORNER

Re render wall complete.

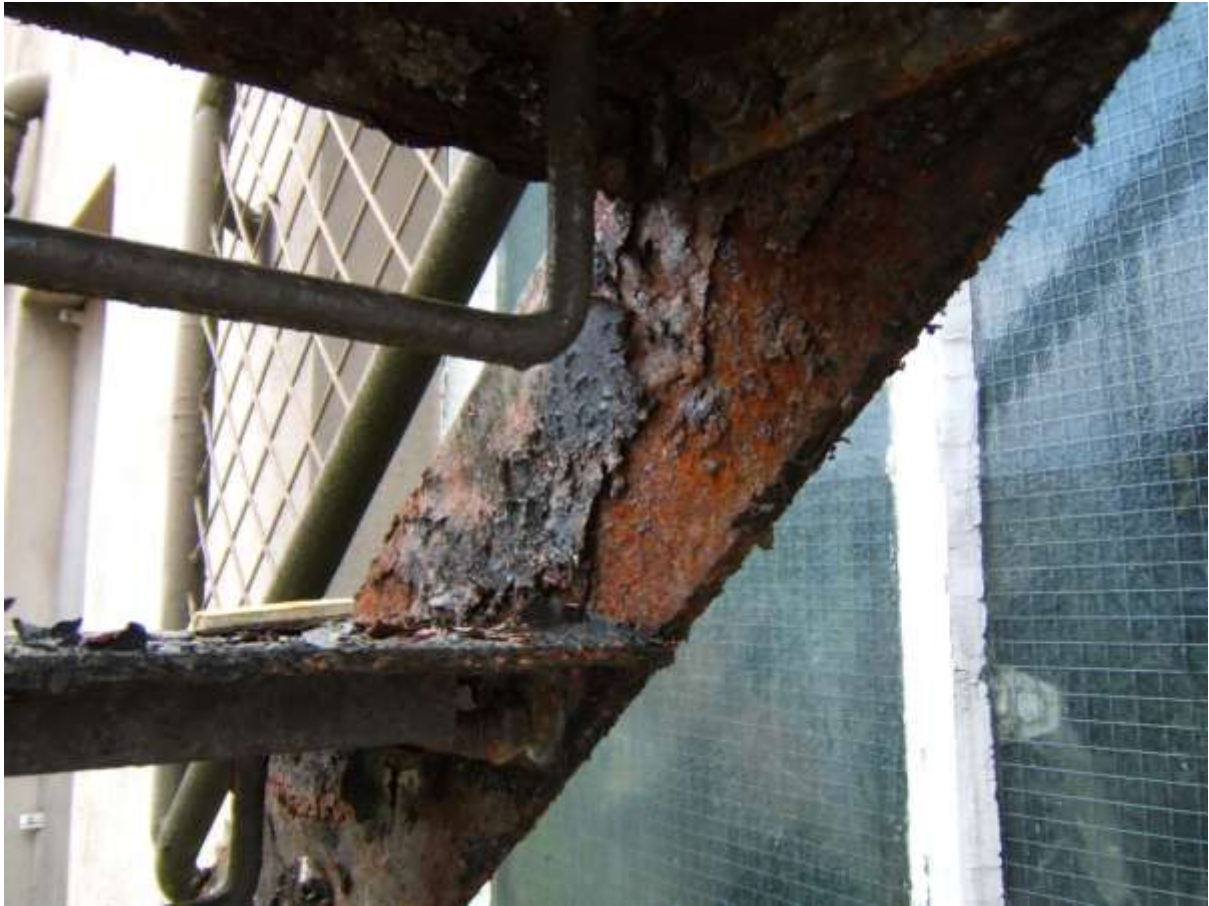
General condition poor with repairs and welding required and repainting throughout if being retained.

TYPICAL DEFECT ON METAL ESCAPE STAIRWAY & PLATFORMS

The existing metal escape stairs and platforms at the side / rear require repairs in part and welding of additional metal plate and repainting if they are to be maintained.

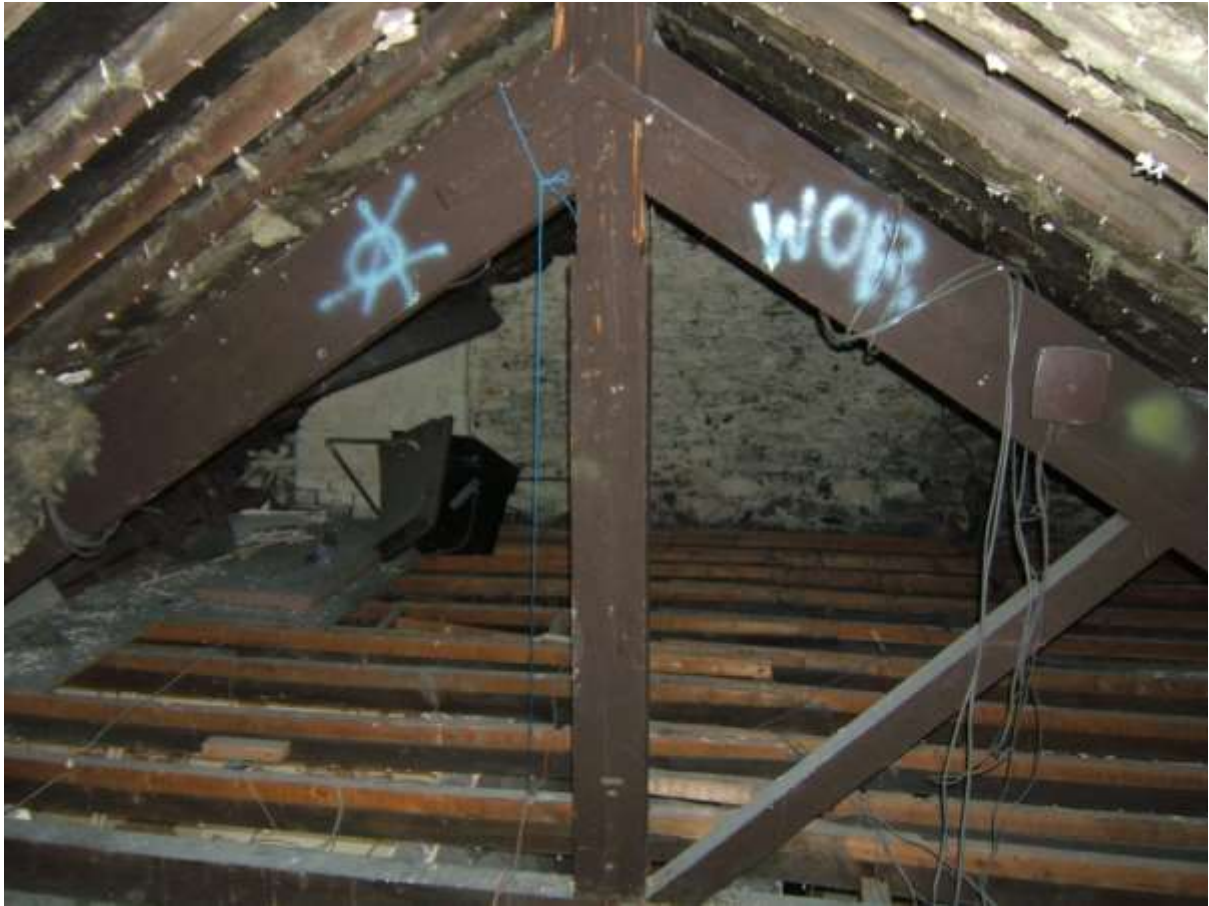
Diagonal timber struts have been removed from the front of both principle trusses weakening the integrity of the strut.

PRINCIPLE TIMBER TRUSS WITH MISSING DIAGONAL SUPPORT STRUT IN ROOF VOID

These must be replaced and secured using bolted metal straps / stirrups at each joint.

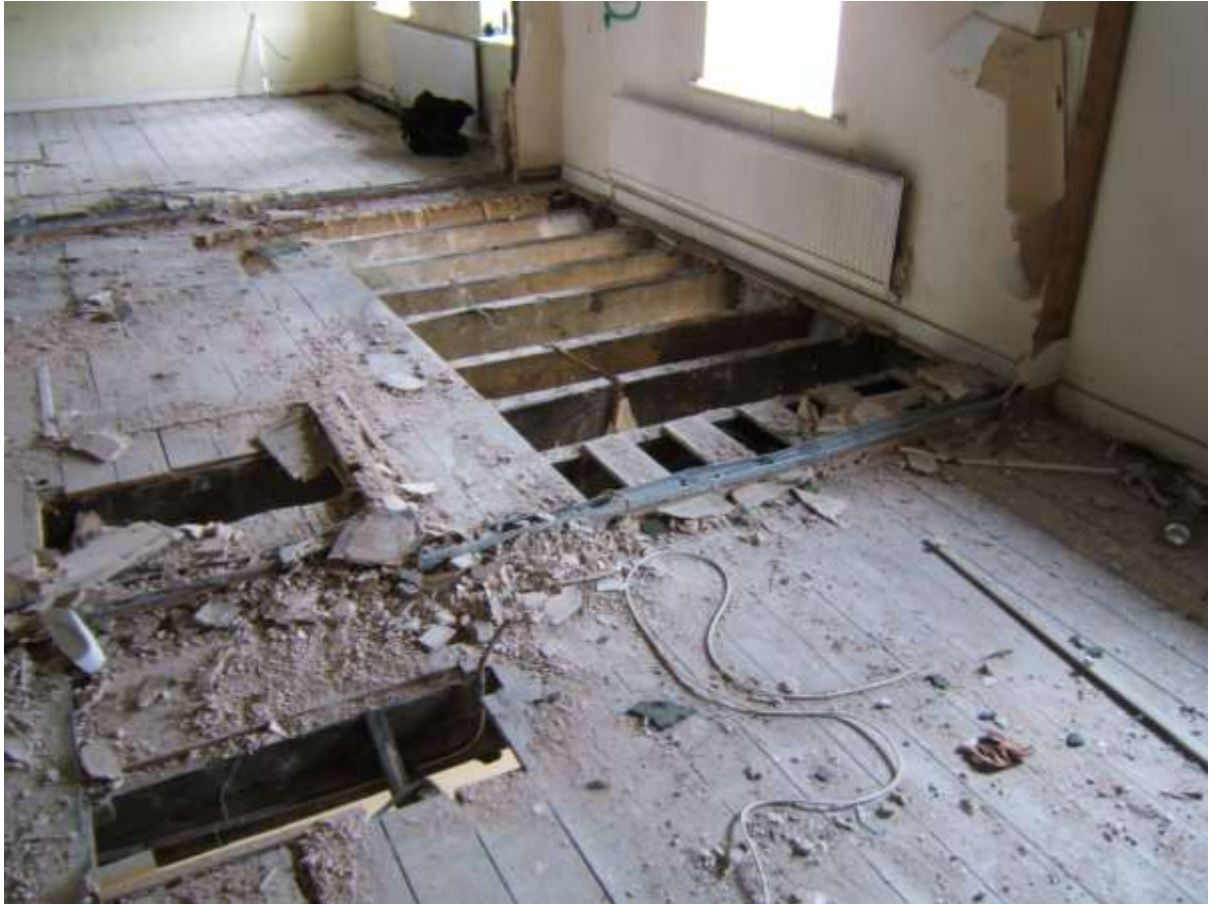
UPPER TIMBER SUSPENDED FLOOR WITH MISSING / DAMAGED FLOOR BOARDS

TYPICAL OF MOST UPPER ROOMS INTERNALLY

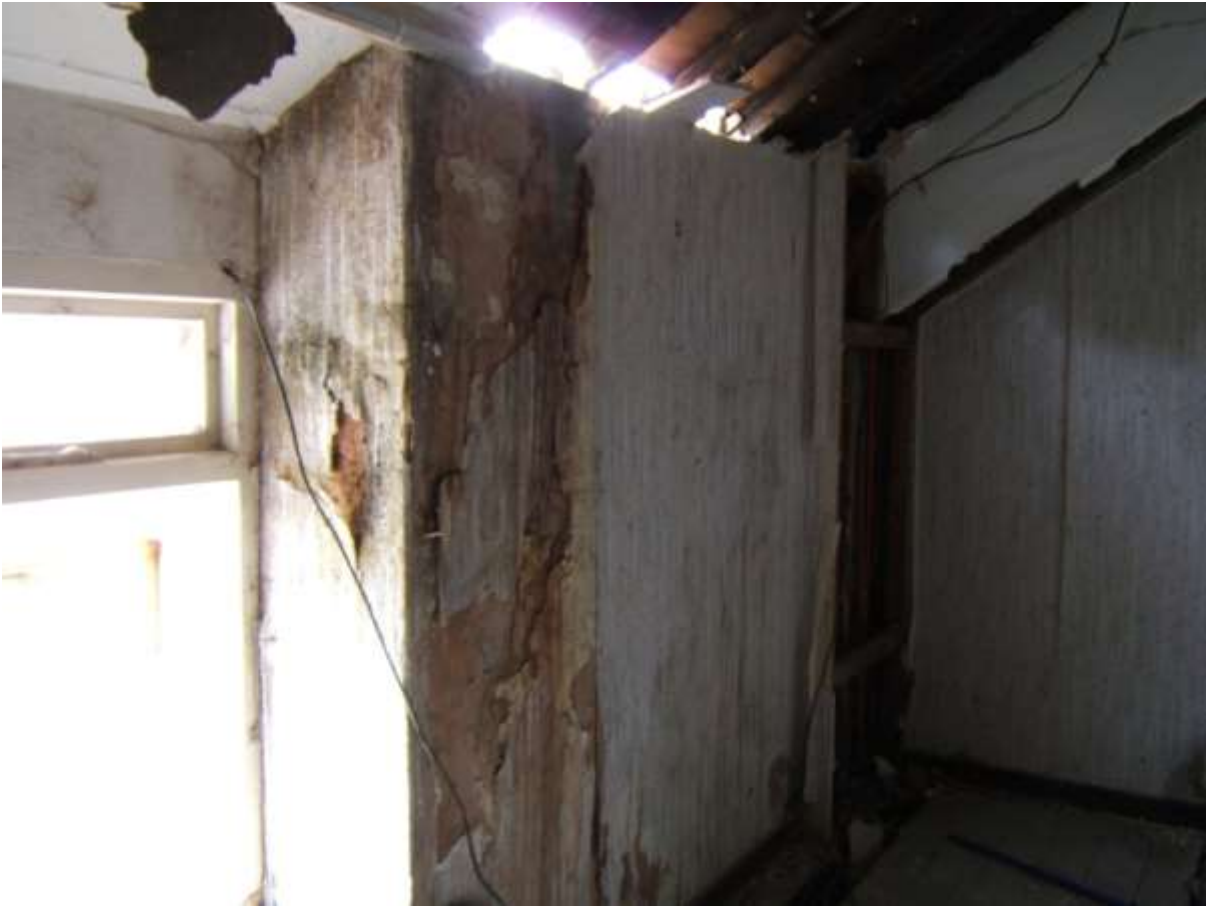
WATER DAMAGED UPPER REAR WALL INTERNALLY

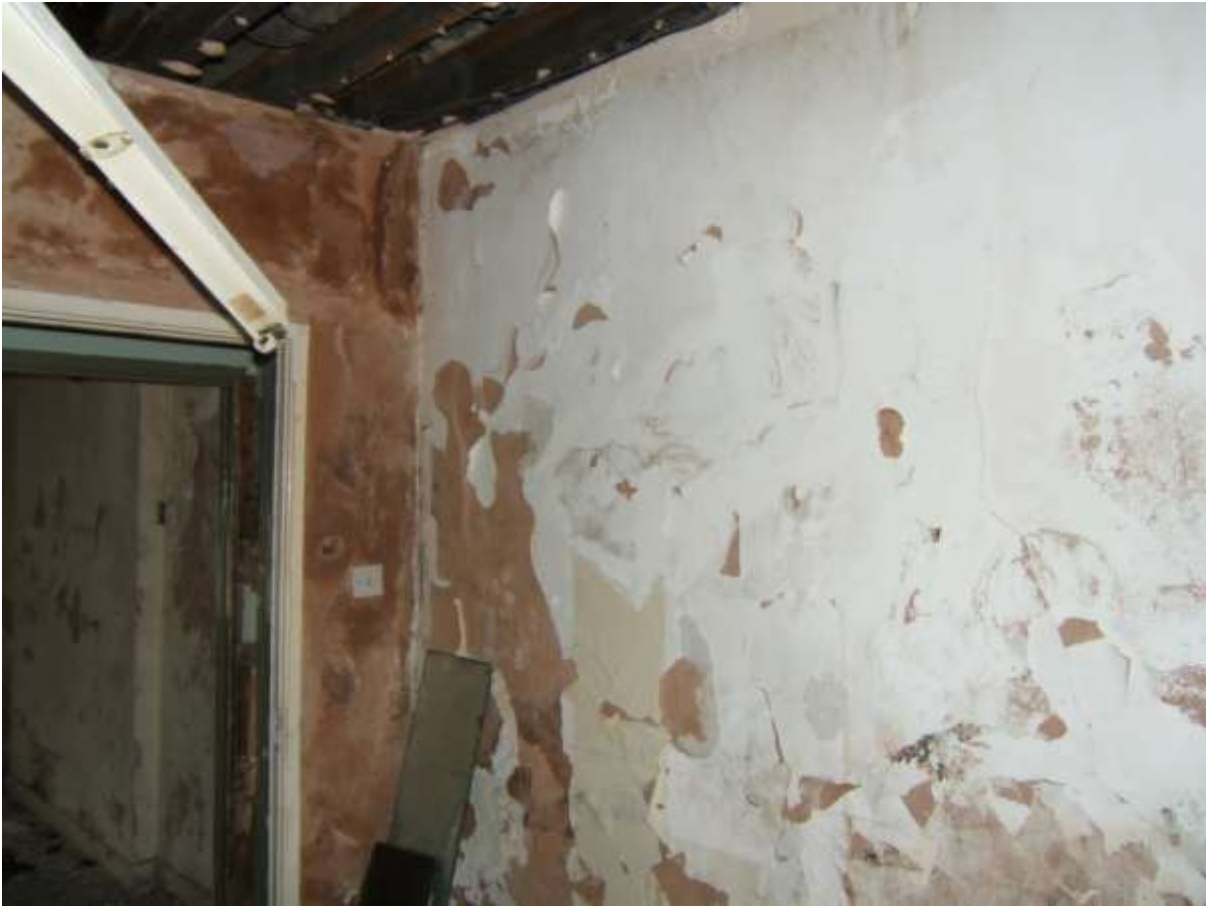
Water ingress through North gable wall.

PLASTER DAMAGED GABLE WALL ON NORTH SIDE FROM WATER PENETRATION

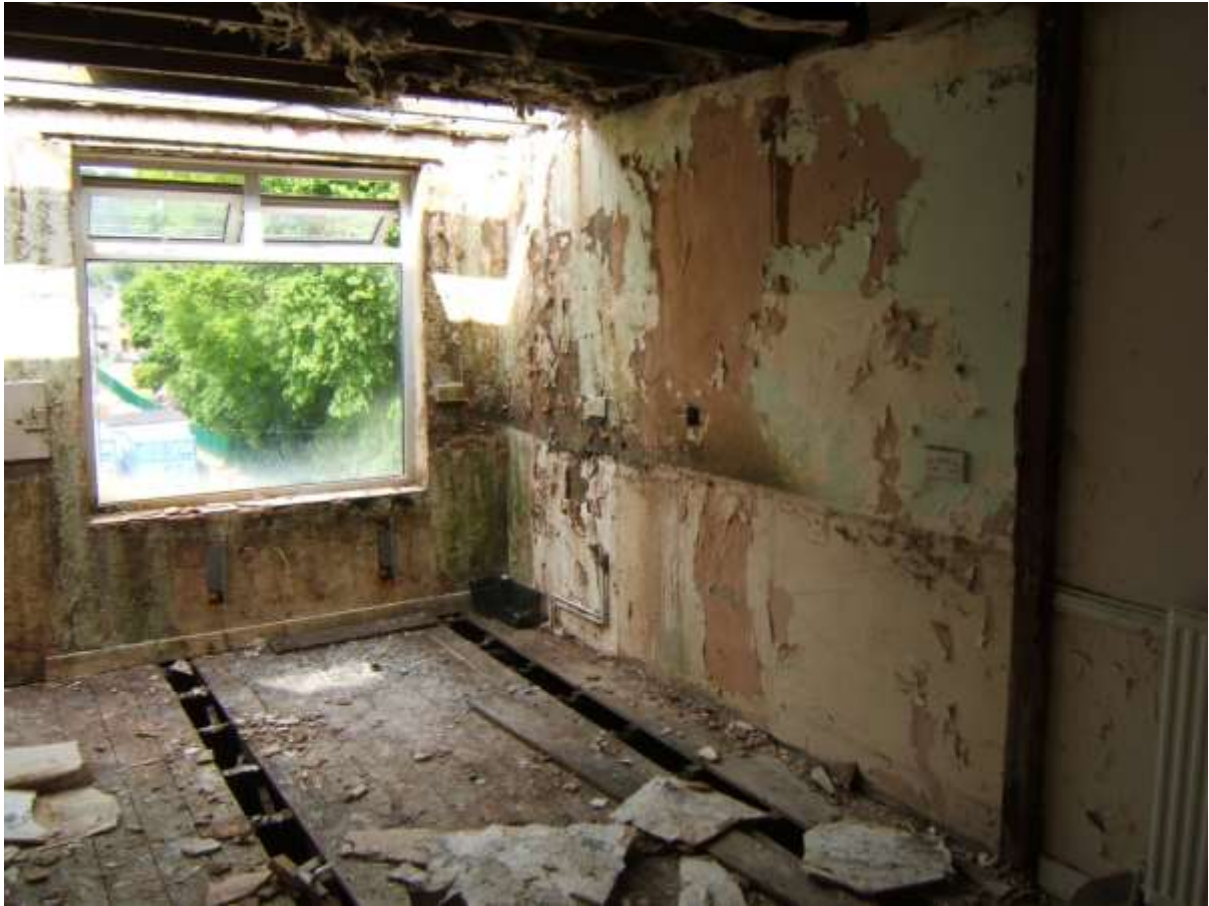
WATER DAMAGE INTERNALLY ON TOP FLOOR REAR ROOM UNDER MISSING ROOF AREA

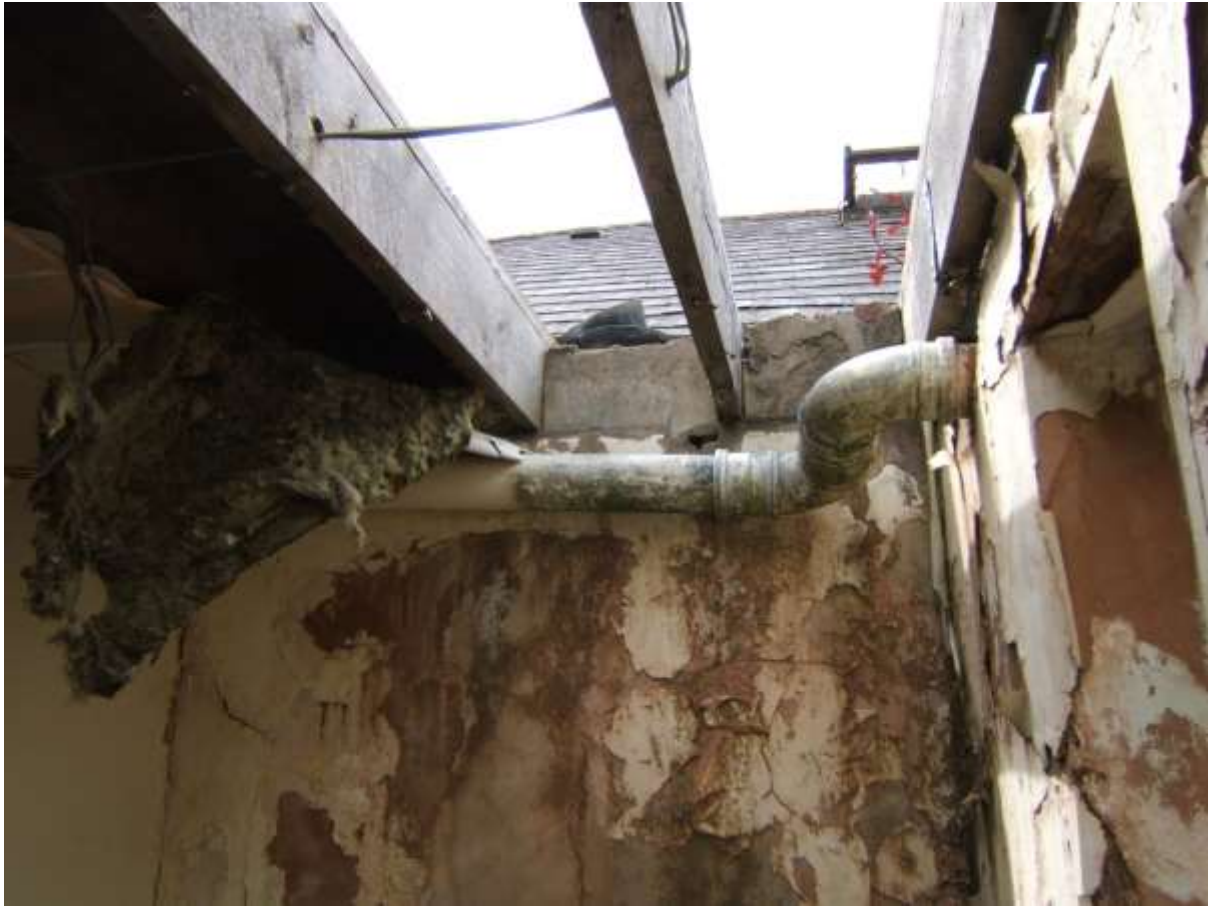
Area on North side exposed to weather due to missing roof membrane with water ingress.

VIEW THROUGH VOID AT MISSING ROOF MEMBRANE & WATER DAMAGED WALLS

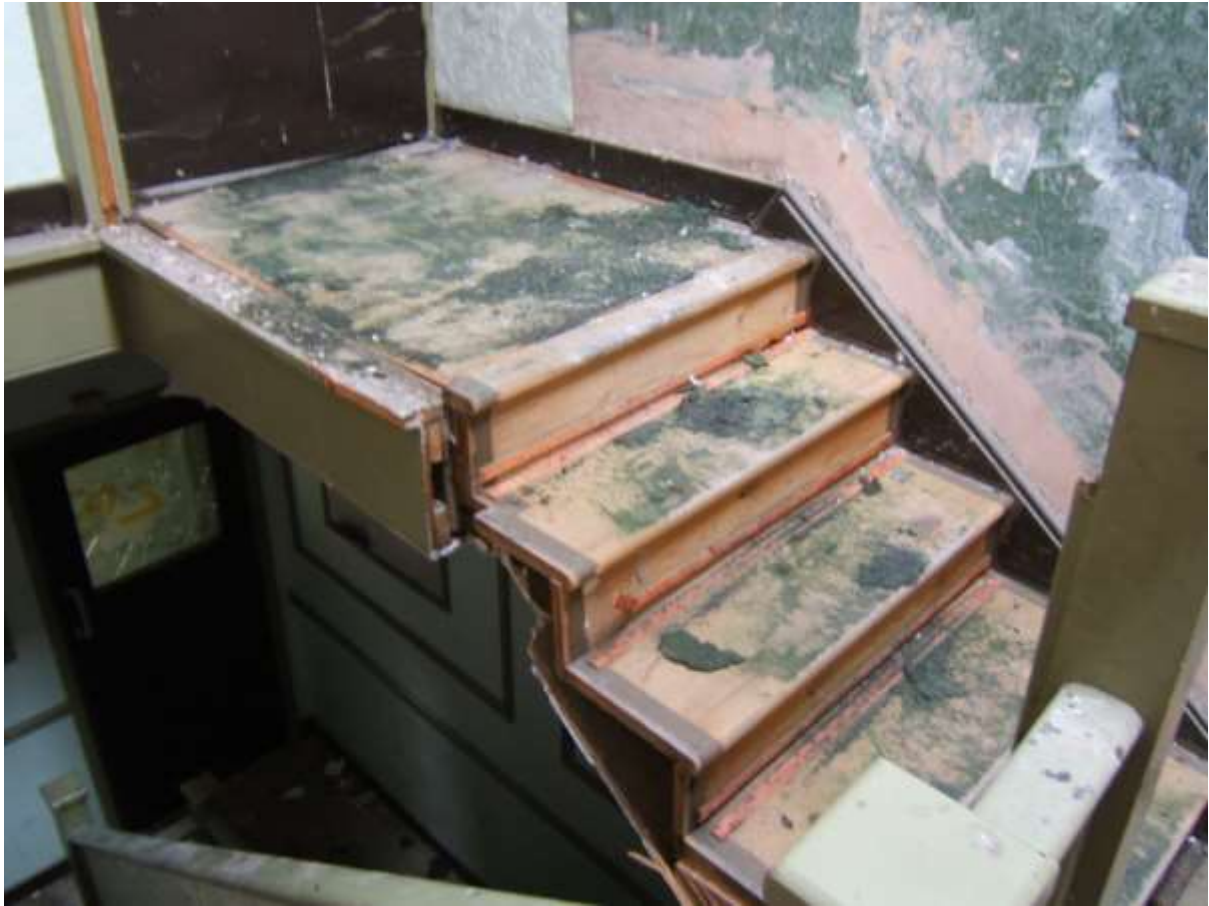
Timber framed stairs partly unsupported due to damaged string and balustrade removed.

DAMAGED & UNSUPPORTED UPPER AREA OF TIMBER STAIRS

This requires supporting and repairs carried out.

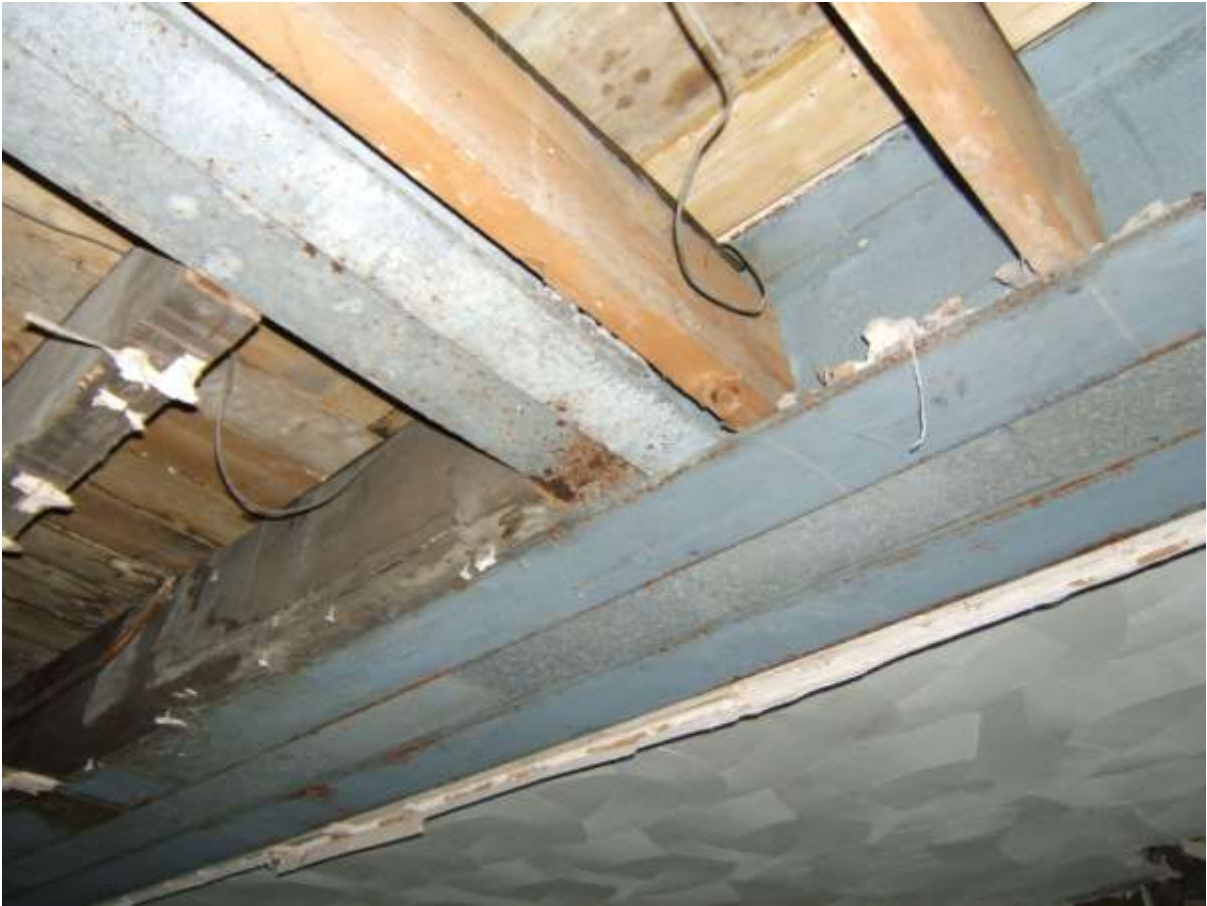
STEEL SUPPORTING MEMBERS ON UPPER FLOOR WITH SURFACE RUST

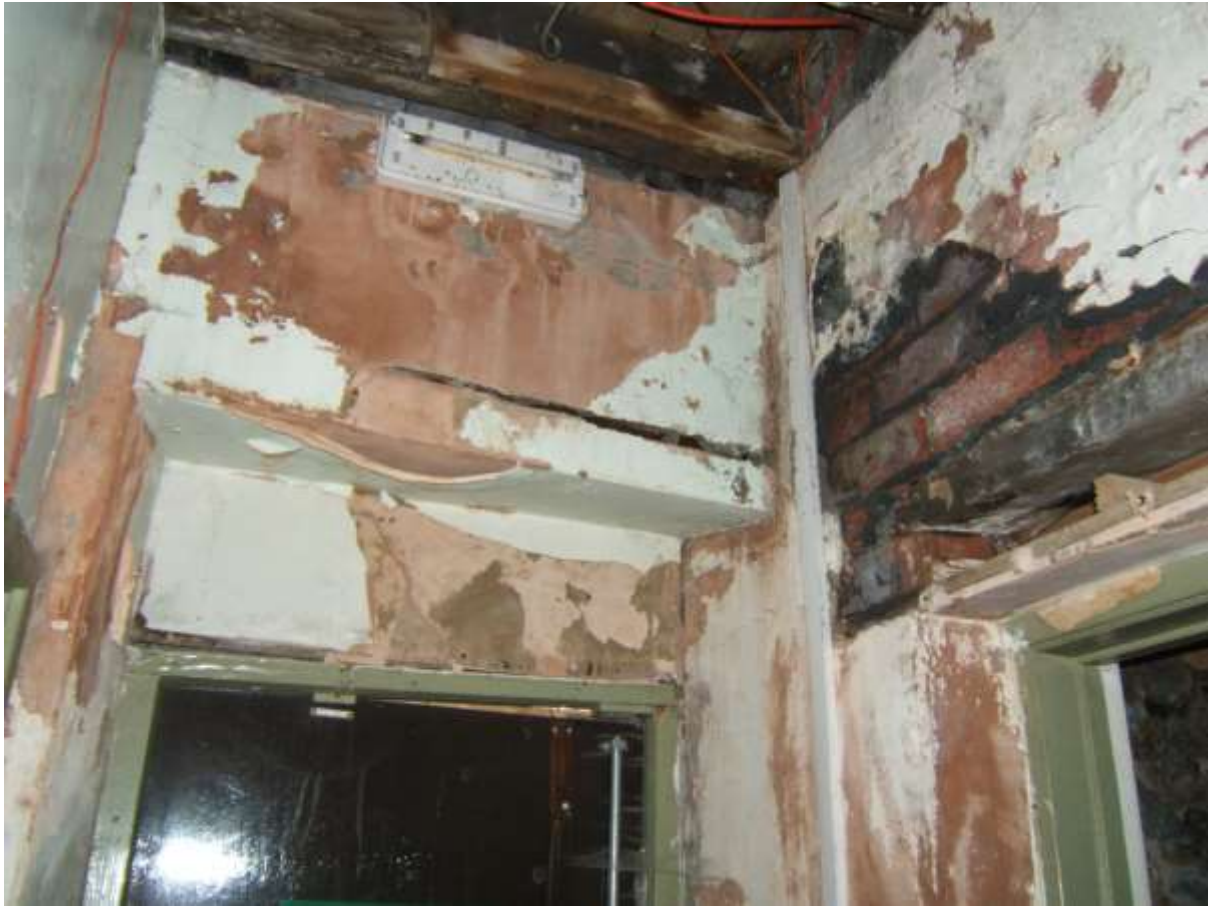
WATER DAMAGE INTERNALLY AT FIRE ESCAPE DOORWAY ON NORTH SIDE
