**BUILDING SURVEY EXAMINATION
AND
REPORT**

**60 GELLI ROAD
PENTRE
S.WALES
CF41 7ND**

**Carried out by
Mr Jeffrey R Tucker, M.R.I.C.S.
Chartered Building Surveyor**

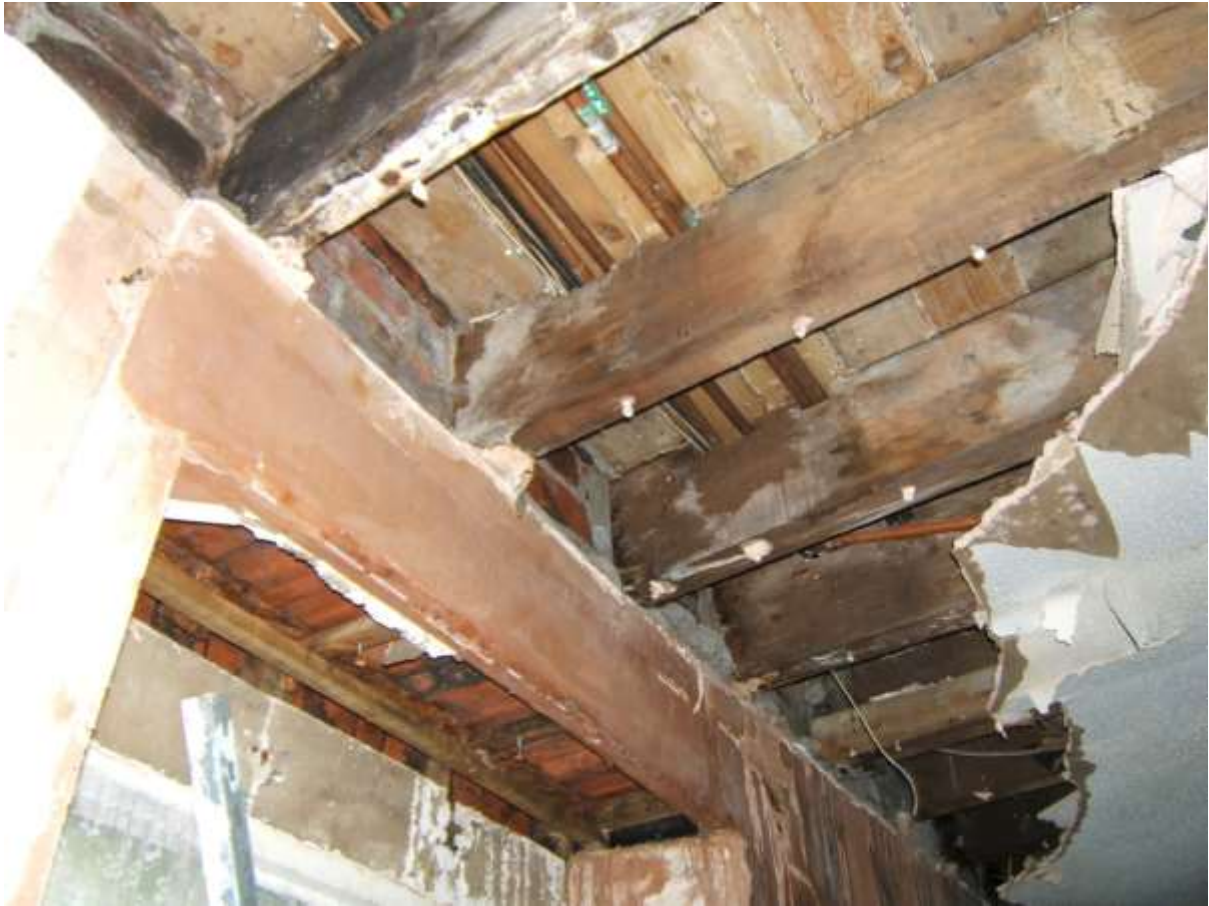
WATER STAINED TIMBER FLOOR JOISTS WHERE BUILT-IN TO REAR WALL ON UPPER FLOOR

A number of timber supporting members are typically built-in to the solid external walls and visually they appear to be generally satisfactory but where damp is evident there may be historic damage to the timber ends which need to be checked before being covered over.

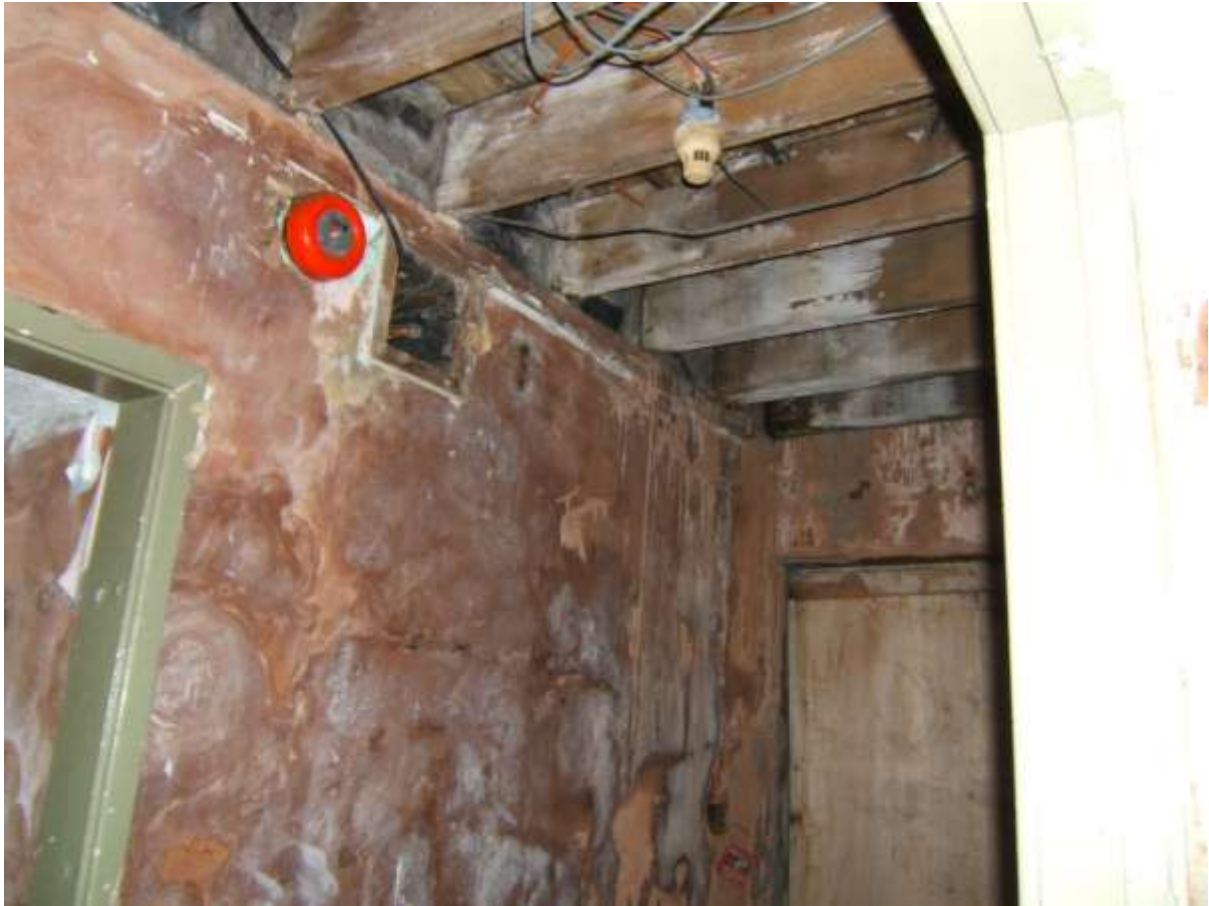
WATER DAMAGED REAR WALL & FLOOR JOISTS IN REAR

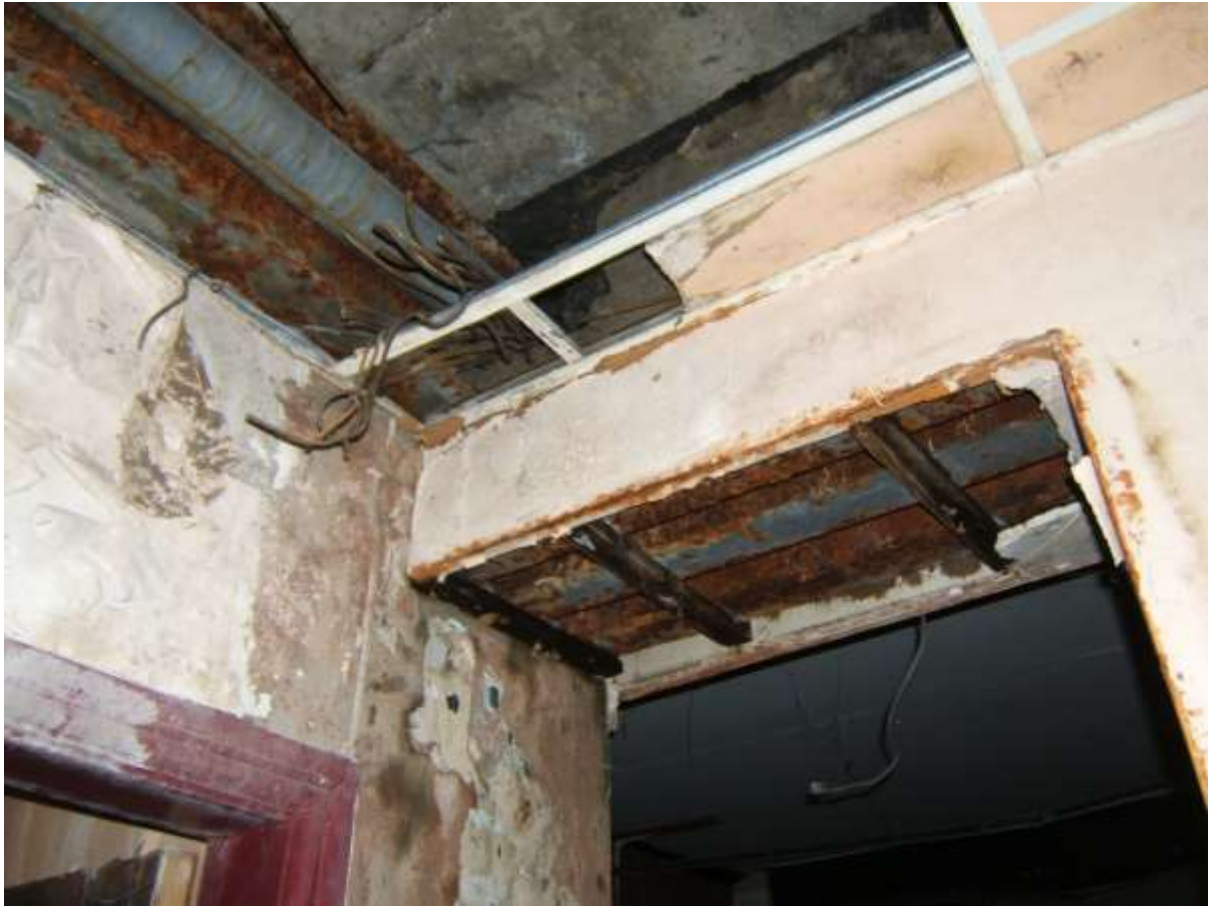
WATER DAMAGED STEEL SUPPORTING MEMBERS INTERNALLY ON GROUND FLOOR
FORMER BAR AREA

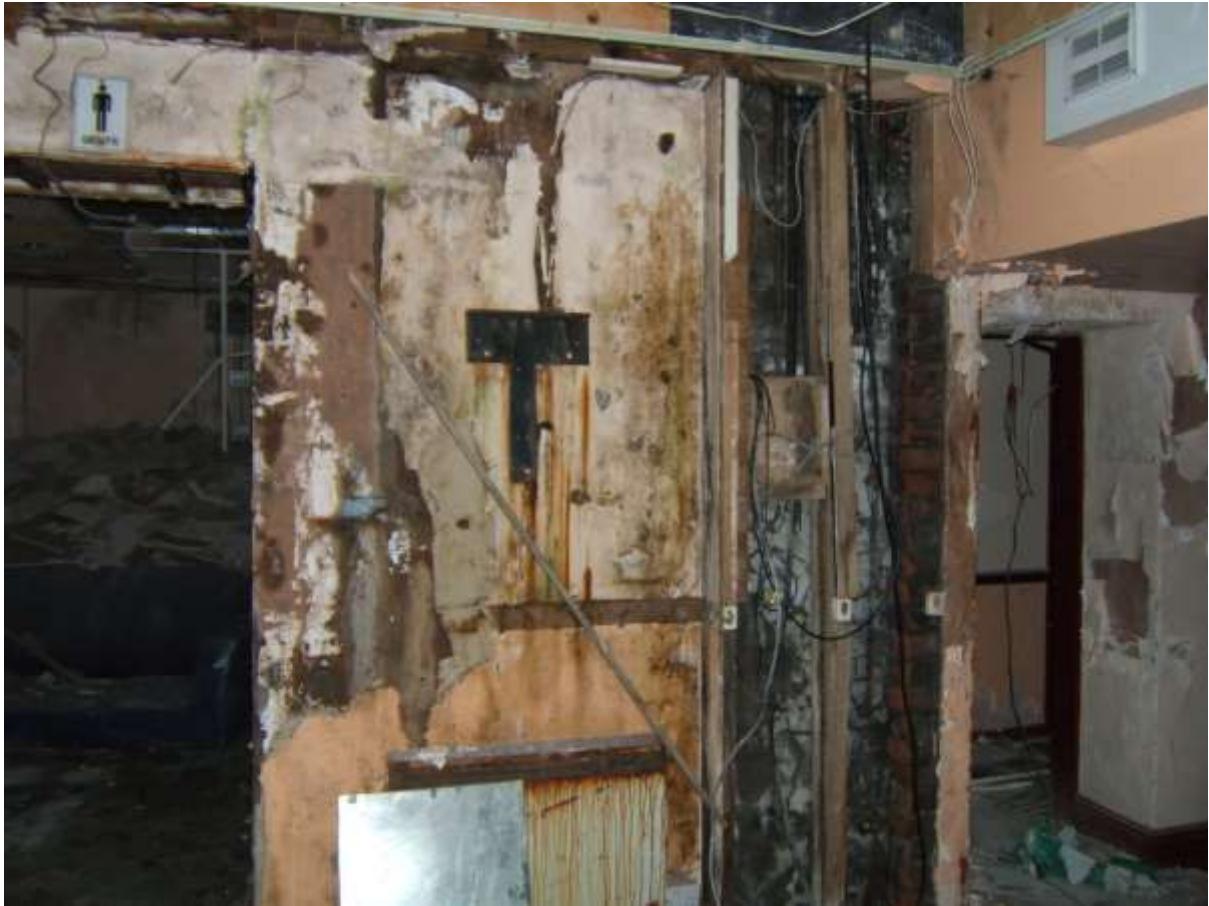
WATER DAMAGED INTERNAL WALL IN FORMER BAR AREA

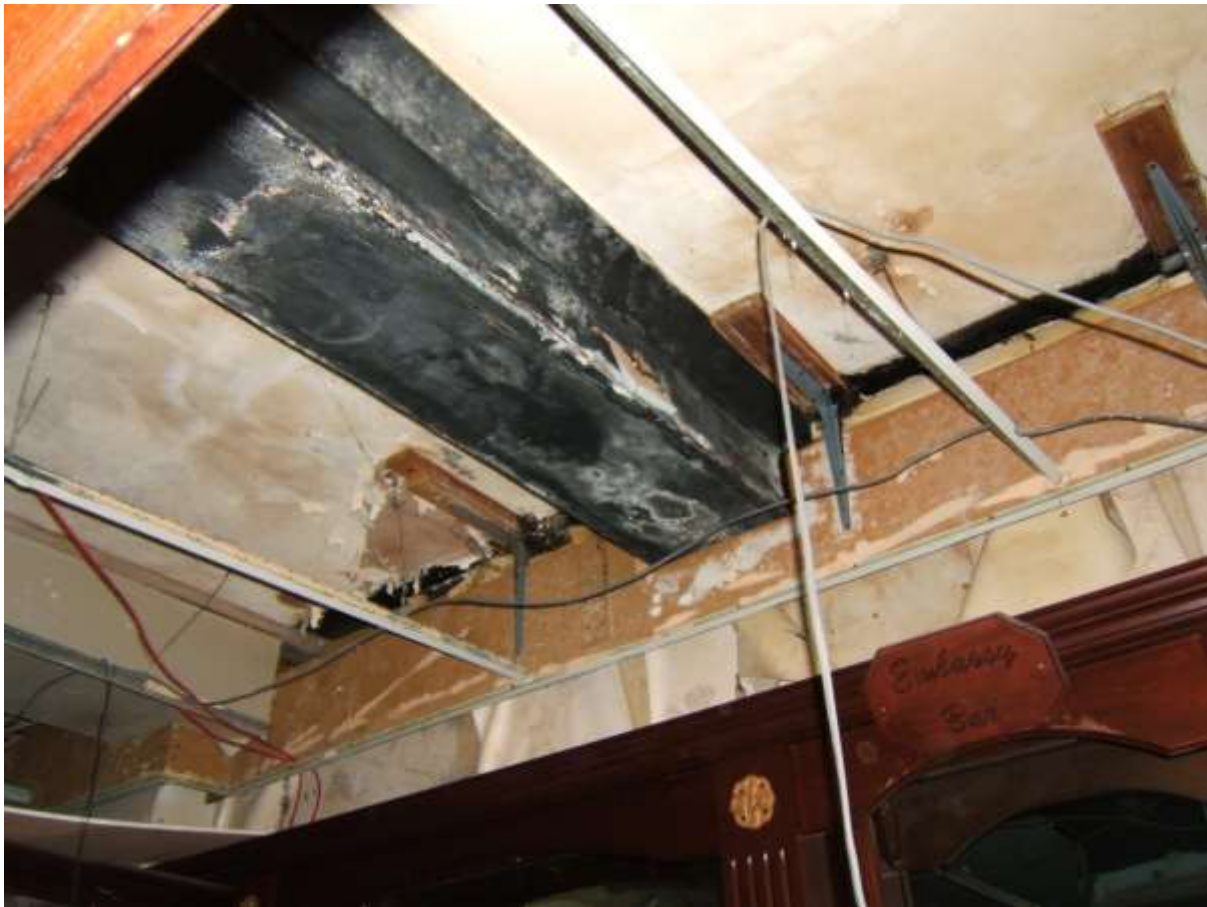
Box-out over steel members at and around northern gable wall area water damaged.

BOXED-IN STEEL SUPPORTING MEMBER IN FORMER BAR AREA ALONGSIDE NORTH GABLE WALL WITH WATER DAMAGE

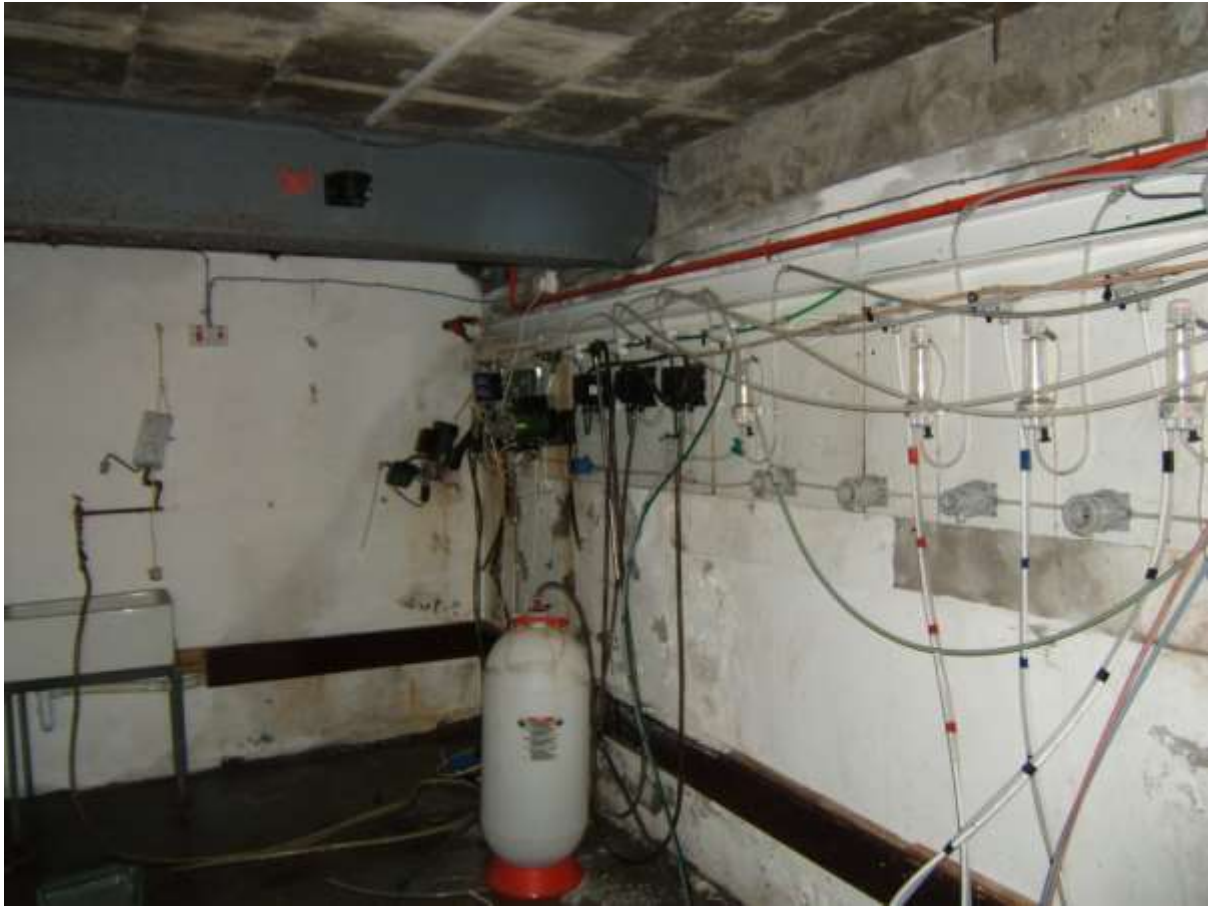
There is also a water leak at the front via the incoming water pipe which is leaking and ponding over the concrete floor causing water damage to the floor slab which requires substantial drying out.

FRONT INTERNAL ROOM IN BASEMENT WITH WATER INGRESS FROM LEAKING WATER PIPE

The main potable water supply was switched off but is leaking at the front basement area which needs to be sealed to prevent ongoing water ingress through the basement floor area.

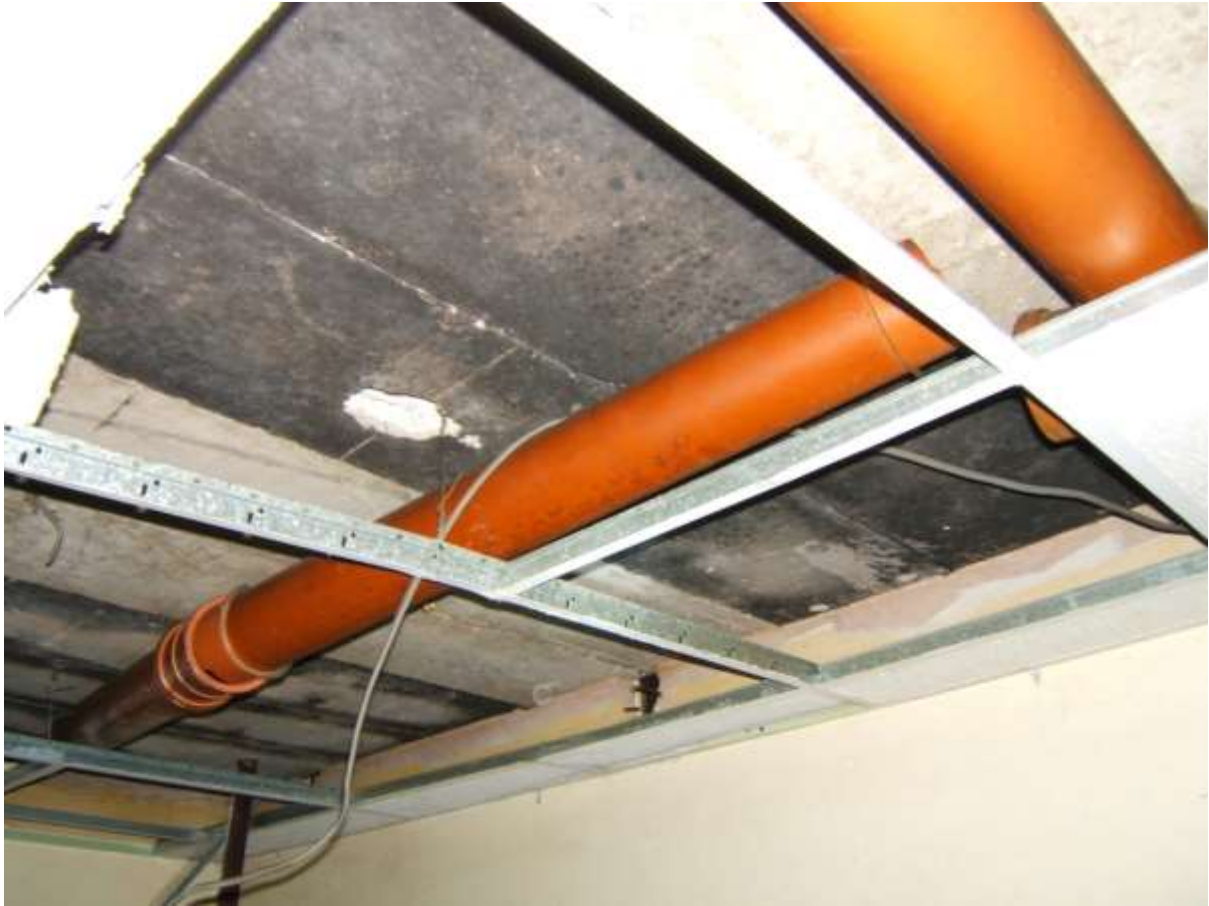
DISPLACED FOUL PIPE IN CEILING VOID OF BASEMENT

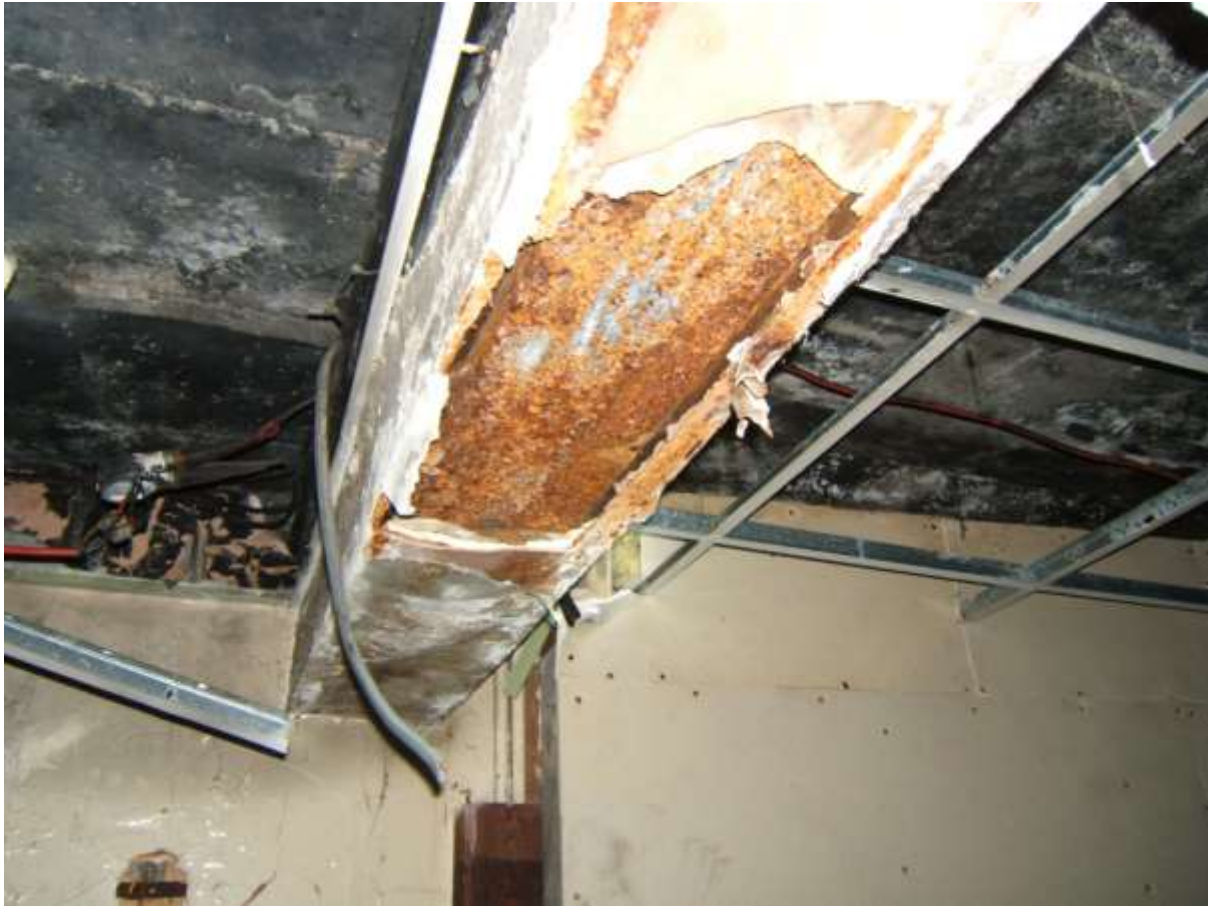
SURFACE RUST ON STEEL SUPPORTING MEMBER IN REAR BASEMENT AREA

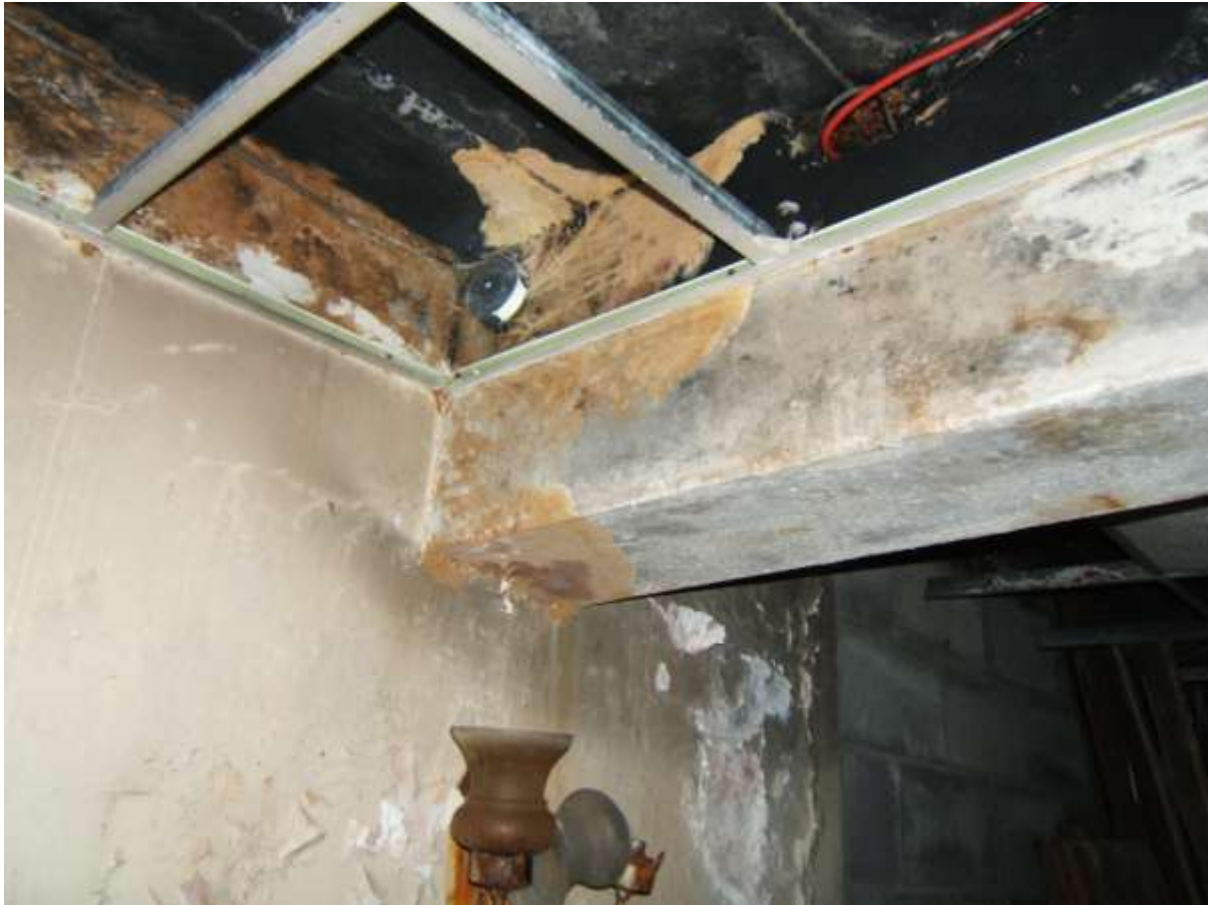
FRUITING BODY AROUND SUPPORTING MEMBER ON REAR BASEMENT WALL / BOX-OUT
DUE TO EXCESSIVE DAMP

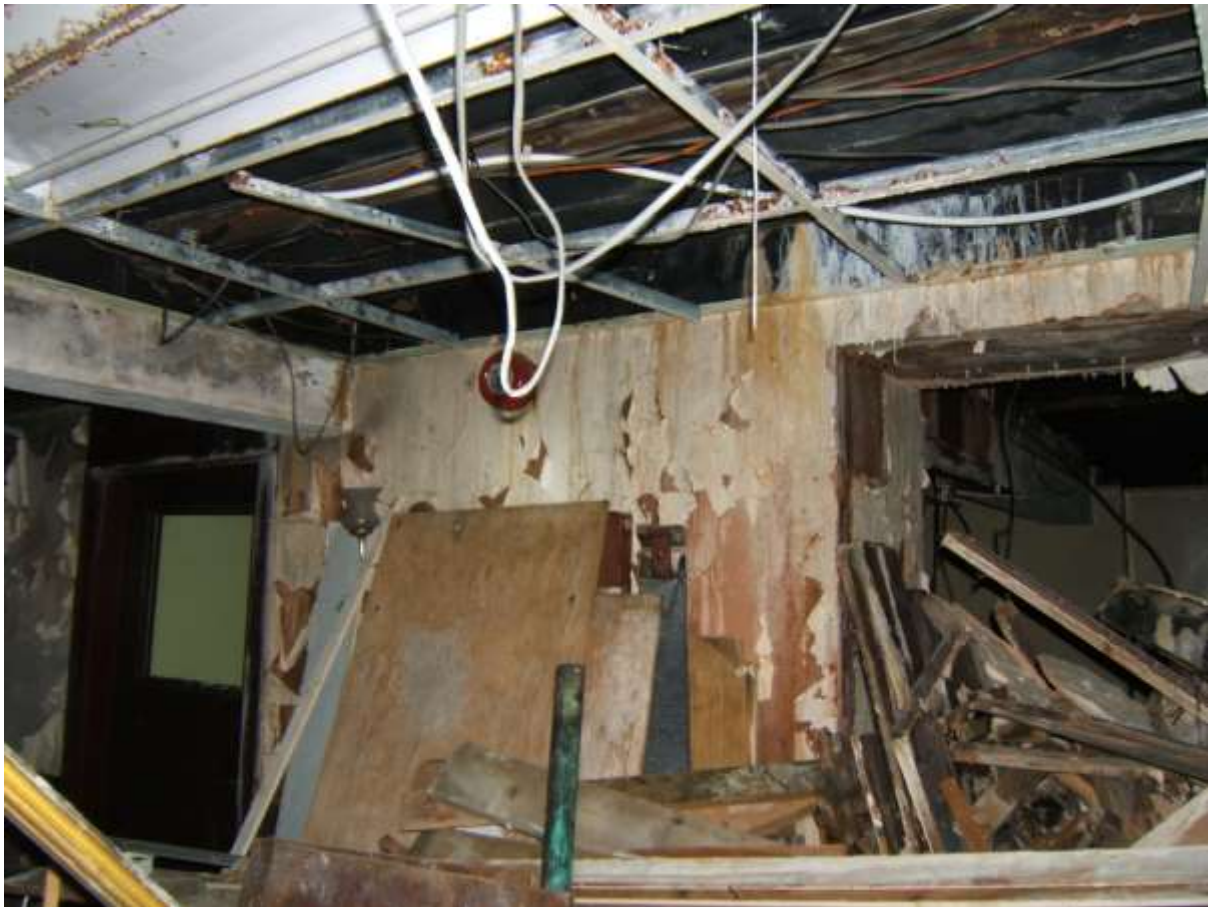
GENERAL VIEW THROUGH REAR BASEMENT ROOM SHOWING DETERIORATION INTERNALLY
FROM WATER PENETRATION FROM ABOVE

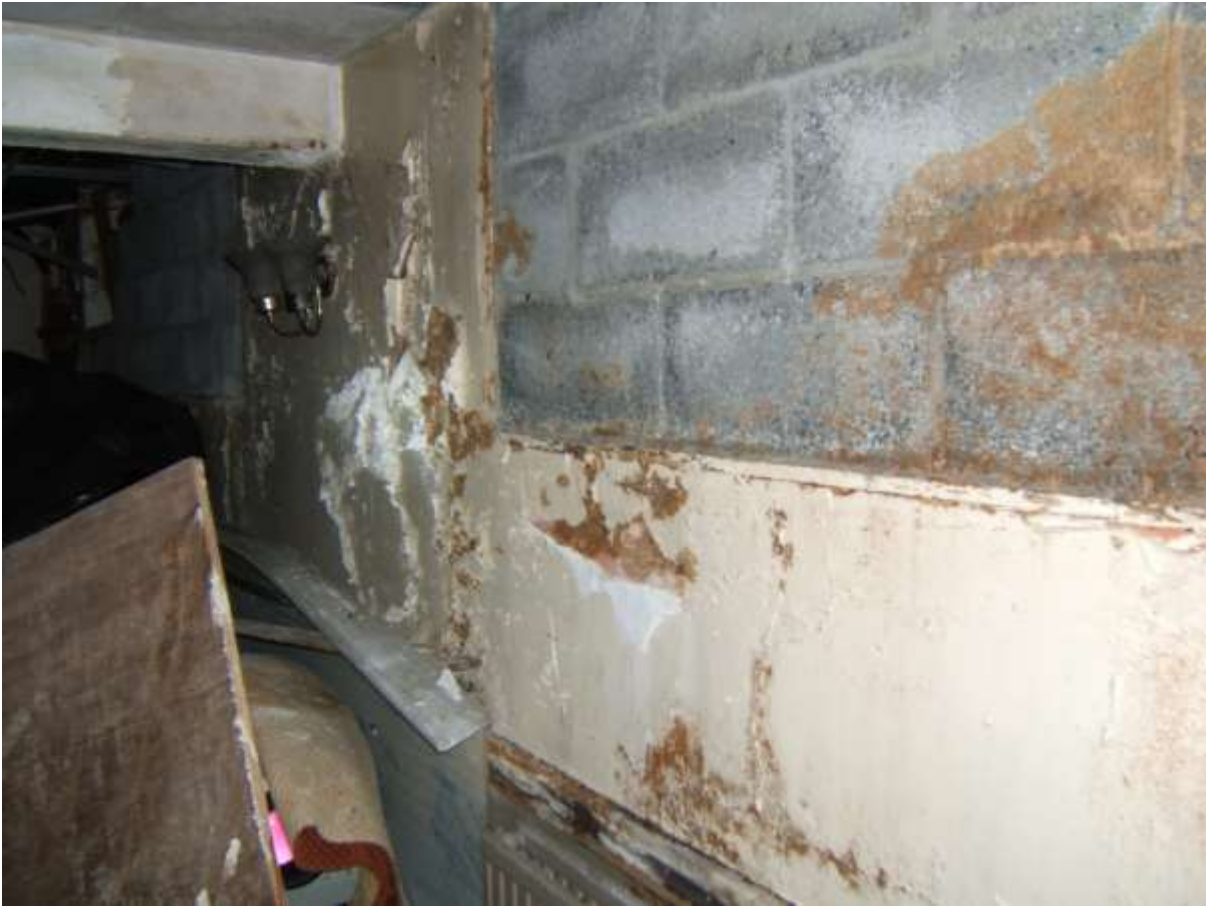
WATER PENETRATION & DAMAGED INTERNAL FINISHES ON REAR WALL OF BASEMENT
